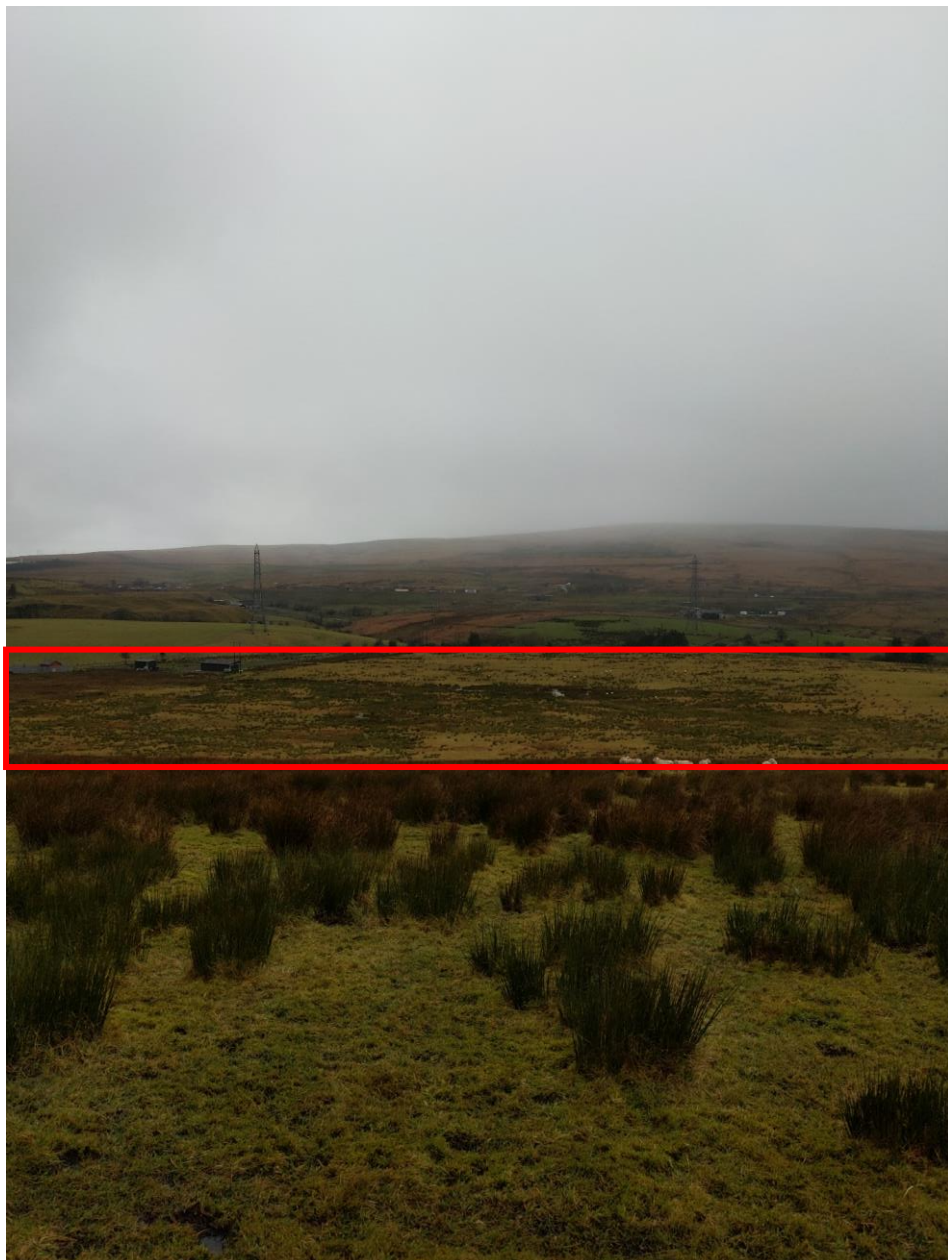
Location: 1
National Grid Reference: SO 09705 08180
Photograph Date: 19/12/2023
Description: Photograph taken facing north. The field (indicated by the red box) is known by the farmer as the 'wet field'. Surface water run off from the top of the hill. No visible streams or flows, just very saturated land.

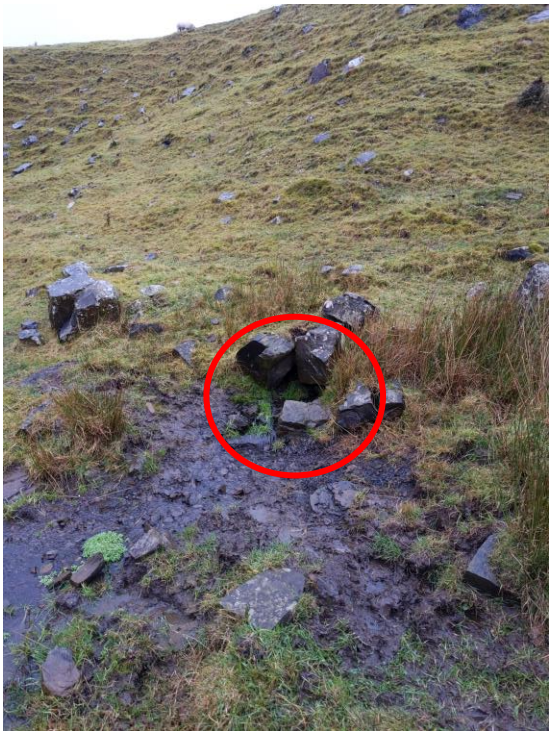
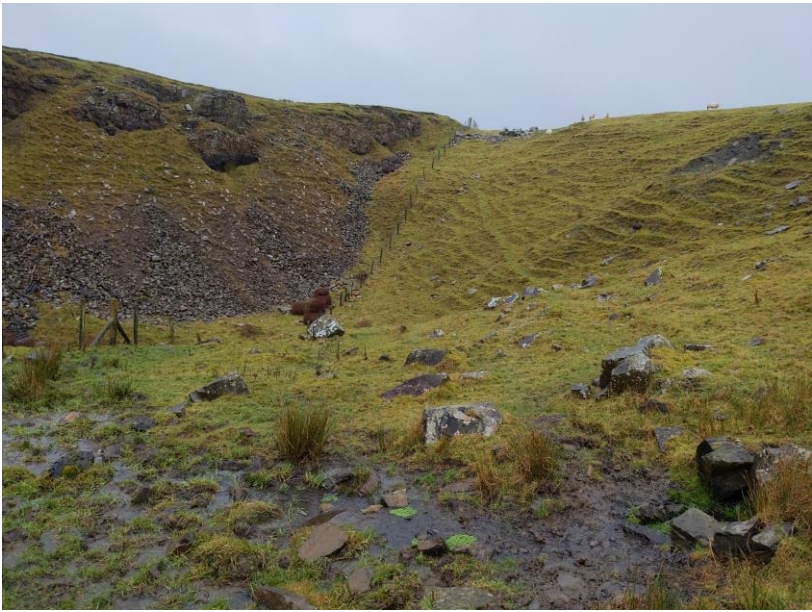
Location: 2
National Grid Reference: SO 09710 08082
Photograph Date: 19/12/2023
Description: Spring which appears to be coming from bedrock coal measures.
Smooth flow towards south, following the topography.

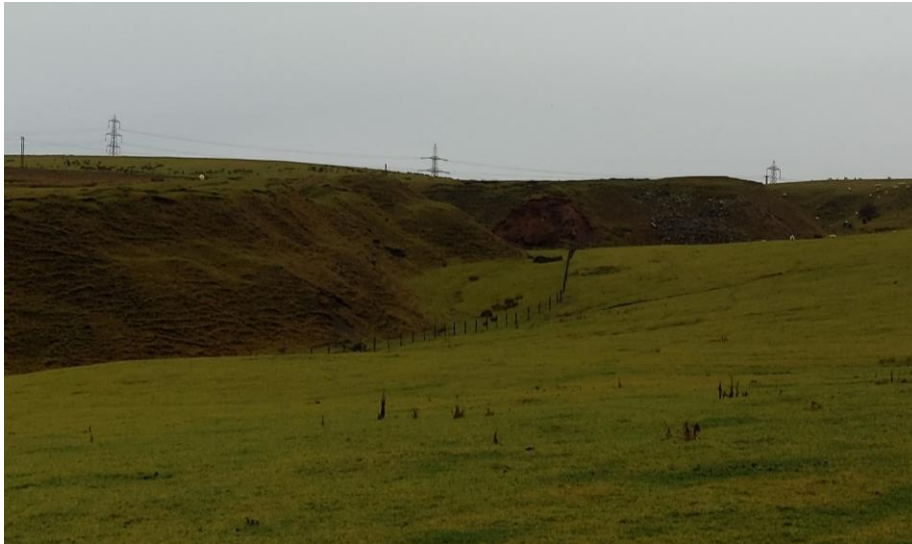
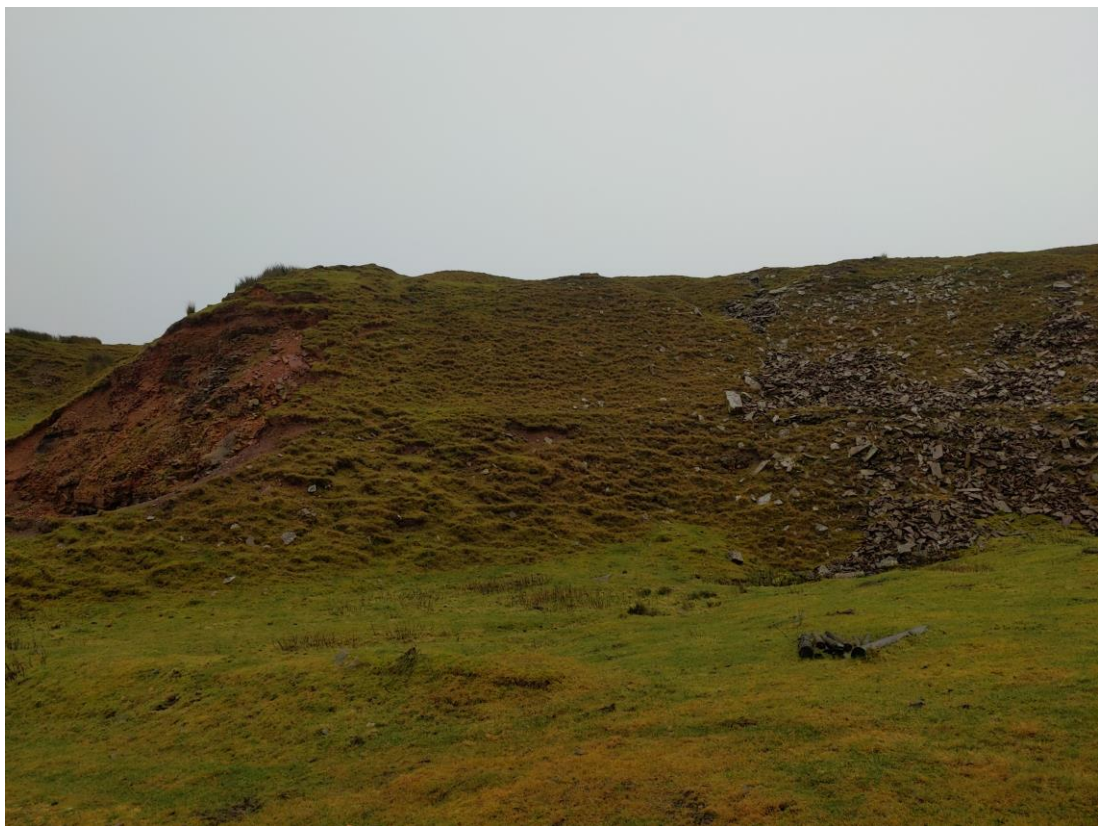
Location: 3
National Grid Reference: SO 09837 08072
Photograph Date: 19/12/2023
Description: Coal mining spoil tip. Evidence of coal industry legacy.

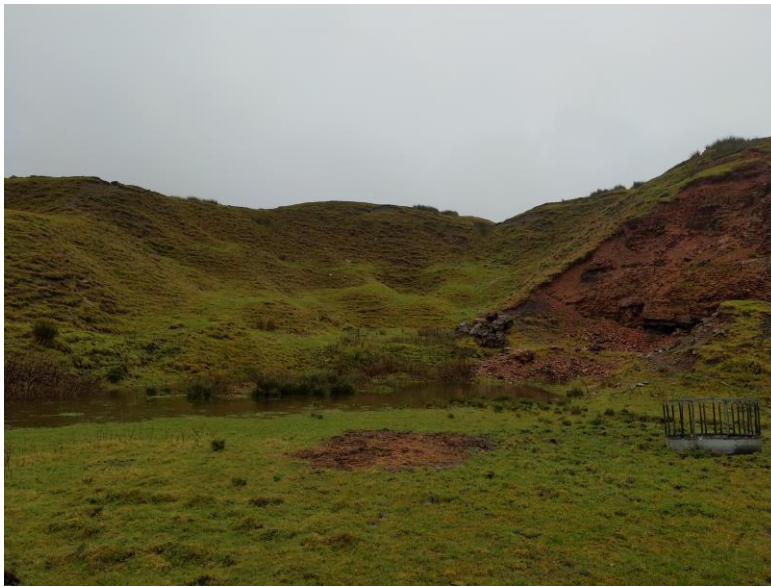
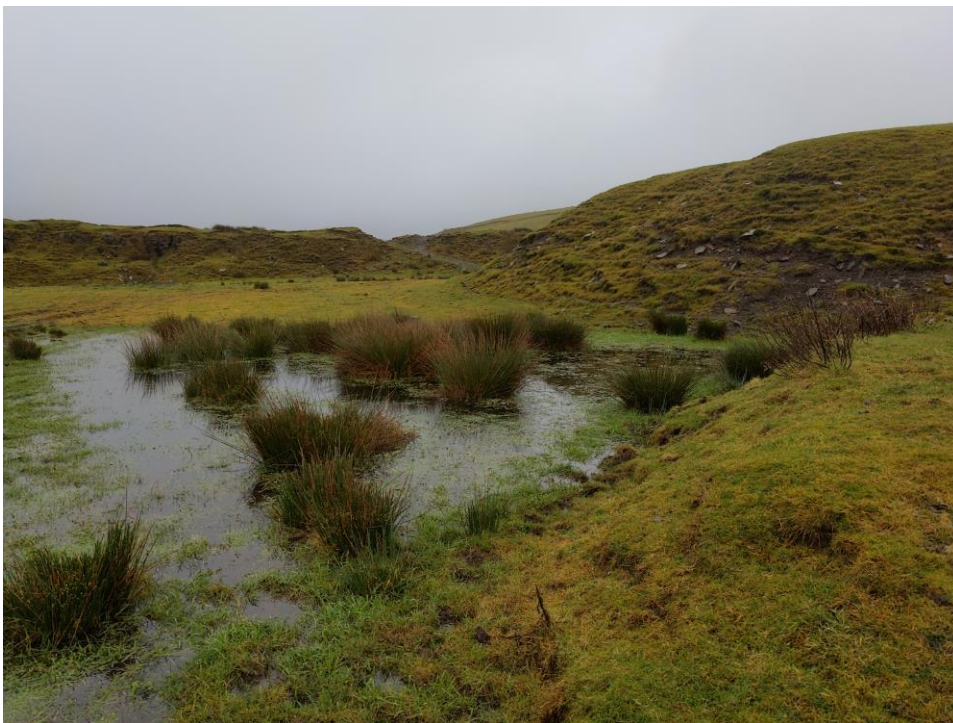
Location: 4
National Grid Reference: SO 09856 08051
Photograph Date: 19/12/2023
Description: Ponded water. No flow

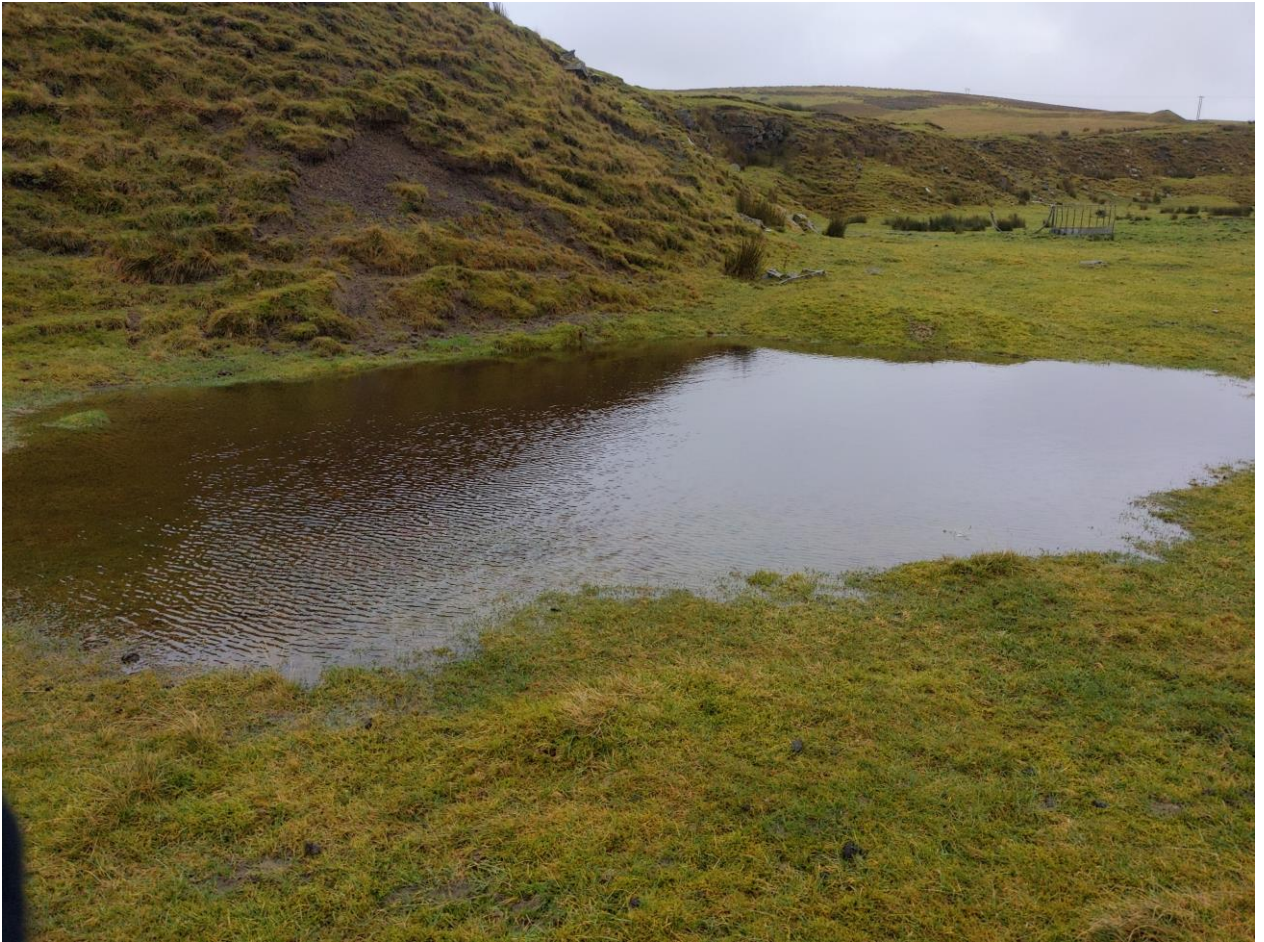
Location: 5
National Grid Reference: SO 09946 08061
Photograph Date: 19/12/2023
Description: Ponded water. No flow.

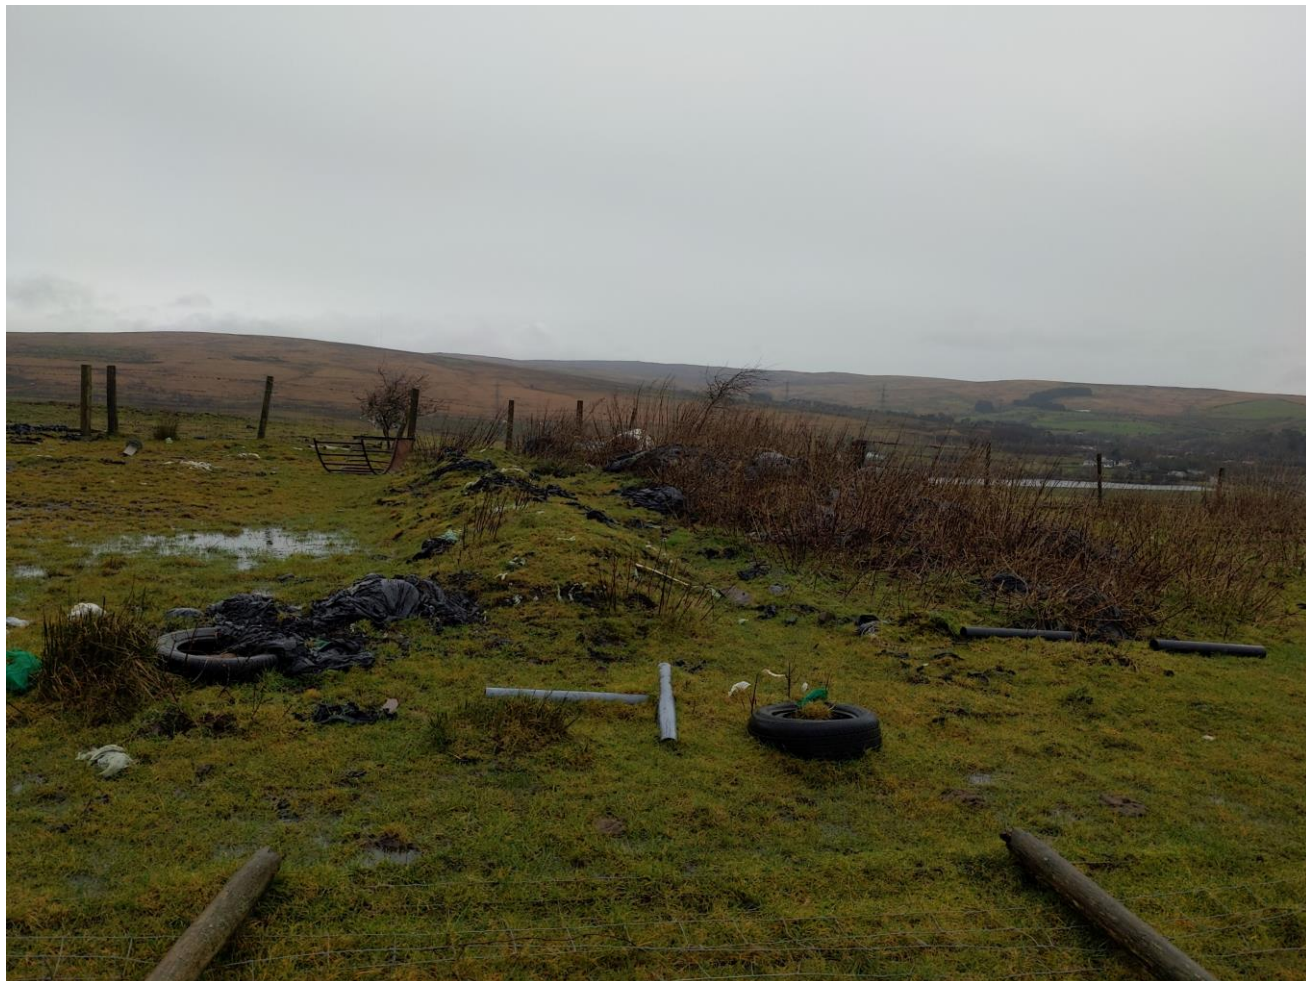
Location: 6
National Grid Reference: SO 10030 08219
Photograph Date: 19/12/2023
Description: Ponded water. Rubbish, lots of tyres present.

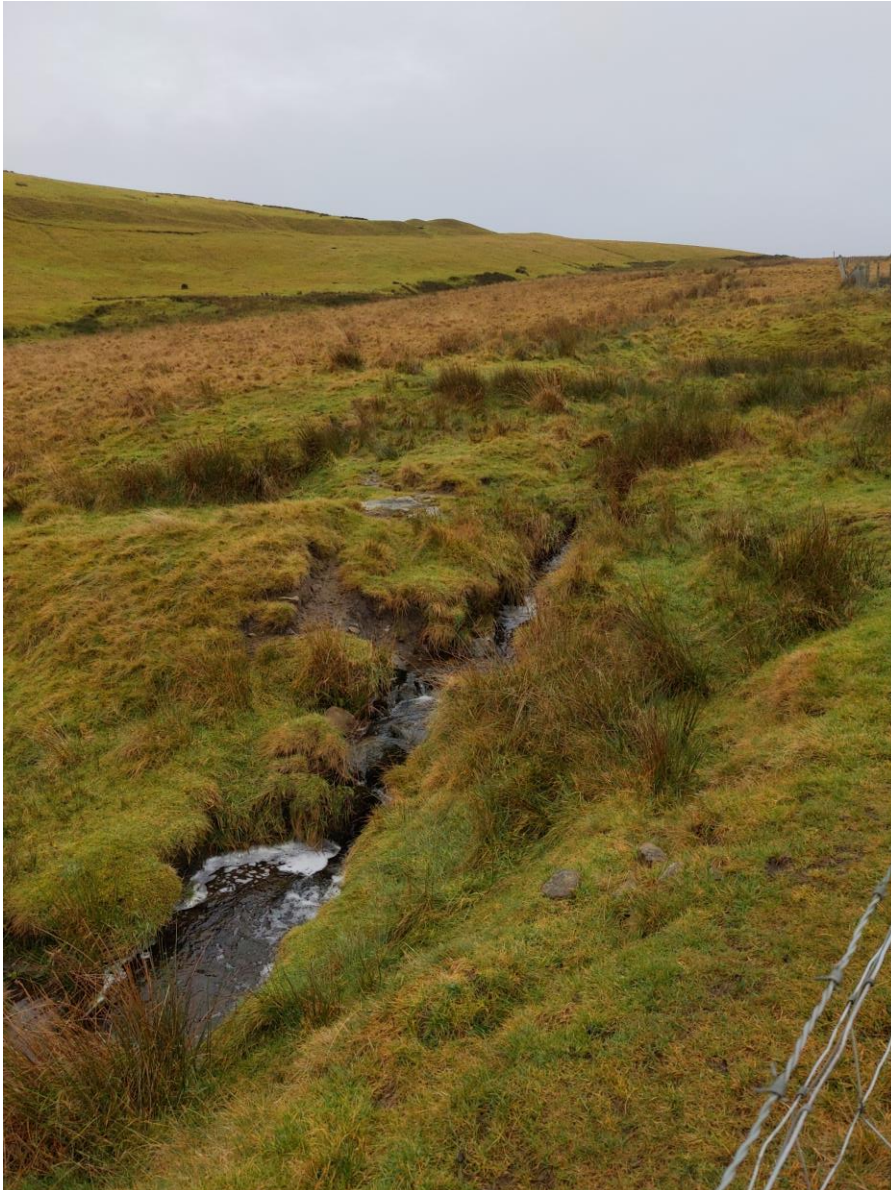
Location: 7
National Grid Reference: SO 10177 07864
Photograph Date: 19/12/2023
Description: Photograph taken upstream.
Right and left bank: Bedrock Boulder Cobble Earth (crumbly)
Channel width: 0.5m
Flow: Freefall / smooth. Flowing east. Appears to be pooling slightly further downstream. Cannot see source.

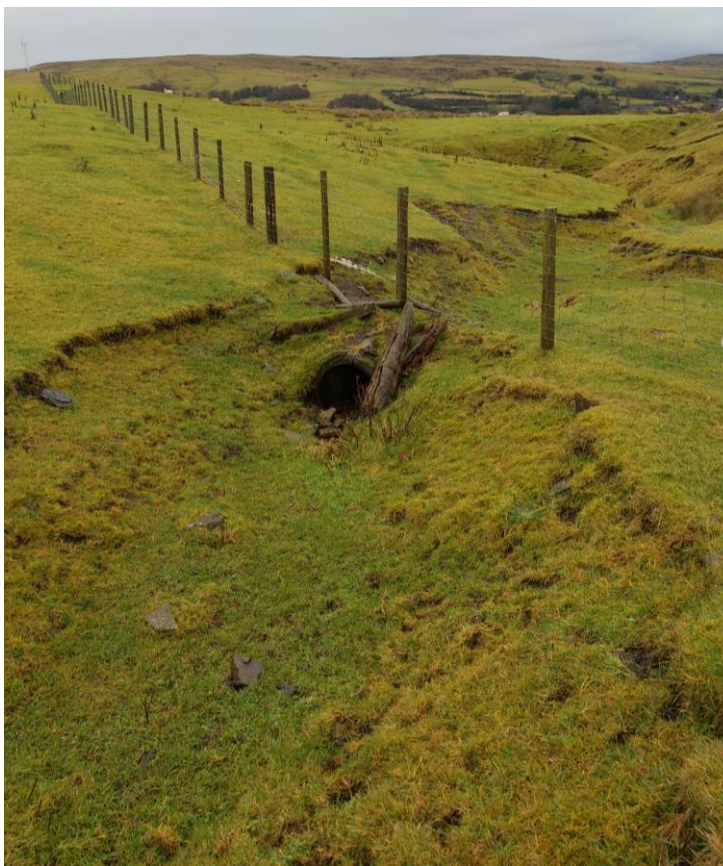
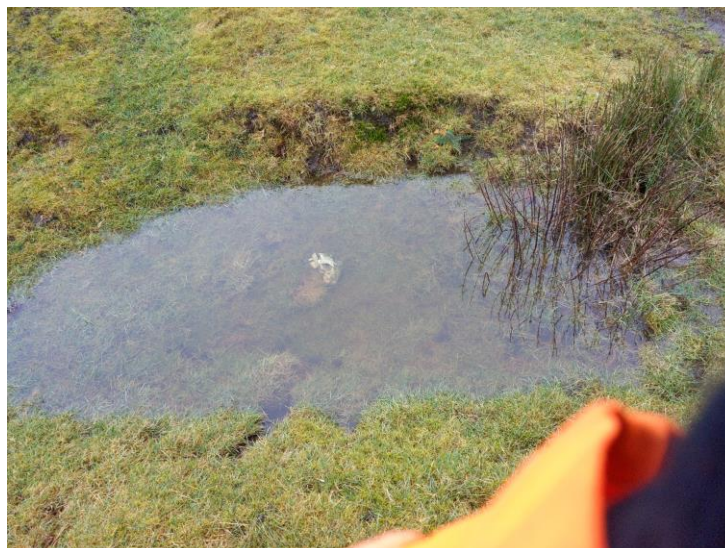
Location: 8

Description: Drainage ditch which was dry for the most part. Some areas of ponded water but no visible flow. Topography and plastic pipe suggests easterly flow direction.

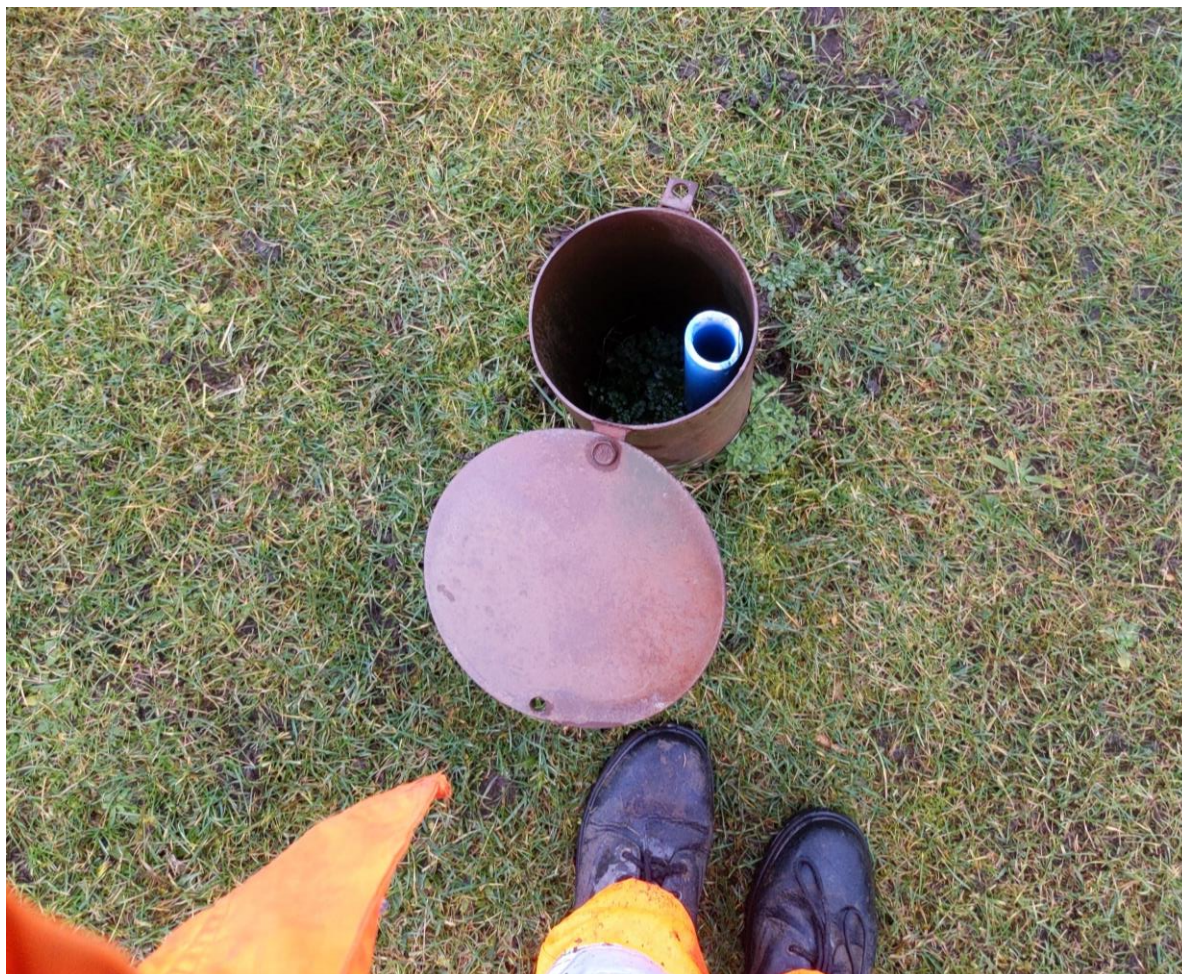
Location: 9
National Grid Reference: SO 10384 08008
Photograph Date: 19/12/2023
Description: Borehole. Installed with 50mm pvc pipe. Unable to take a dip to water or dip to base measurement.

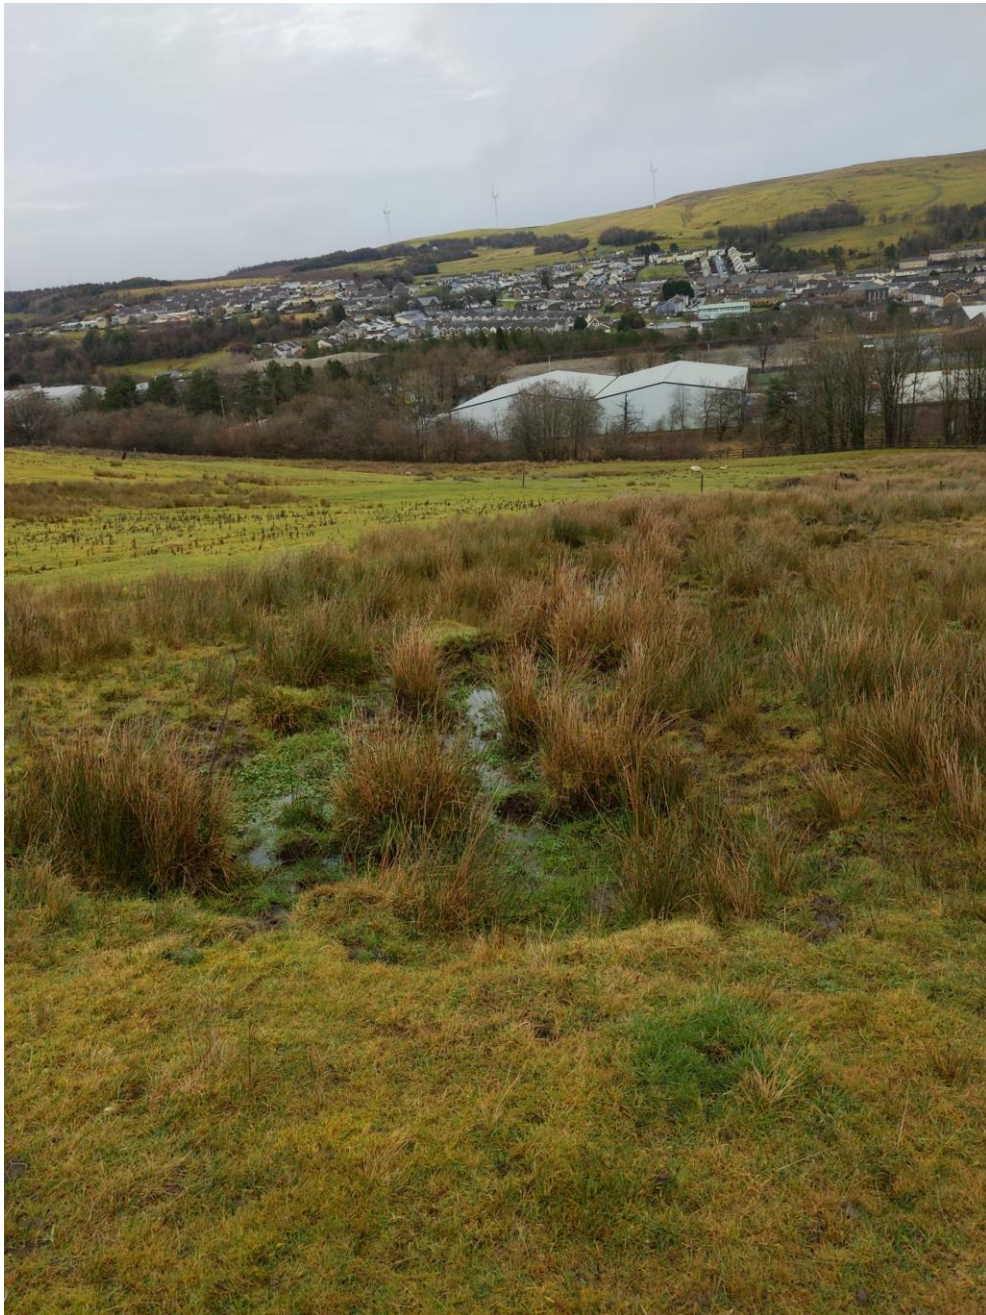
Location: 10
National Grid Reference: SO 10429 08007
Photograph Date: 19/12/2023
Description: Whole area saturated. Unable to tell the extent.

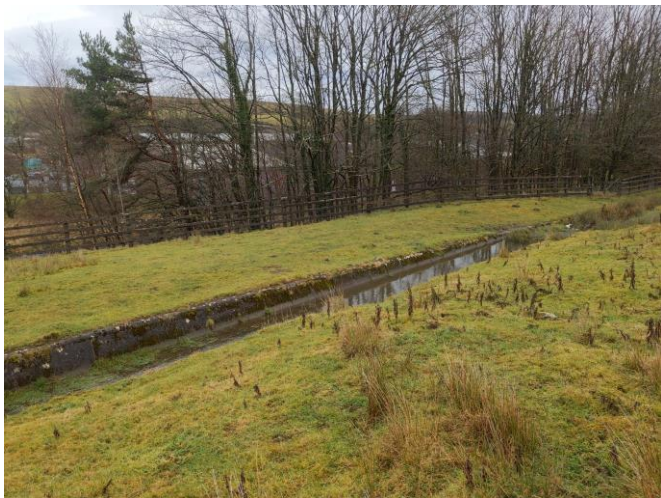
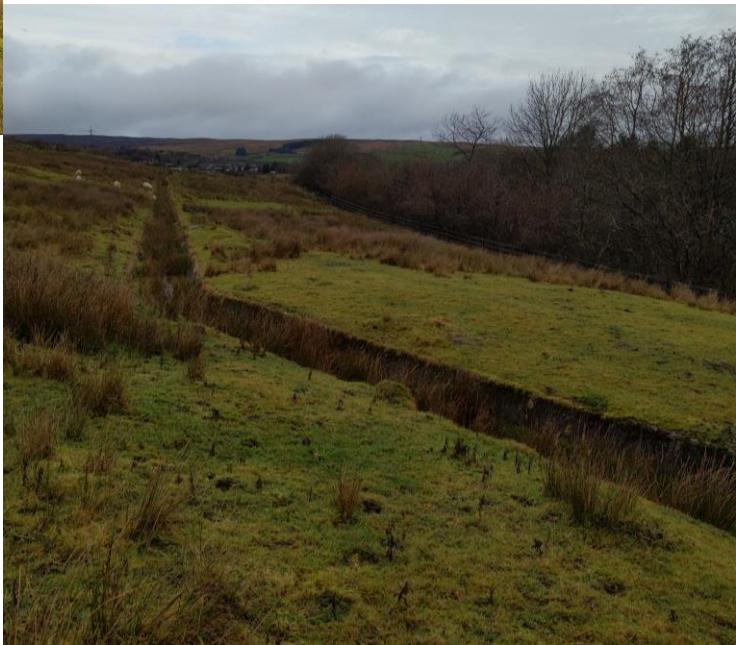
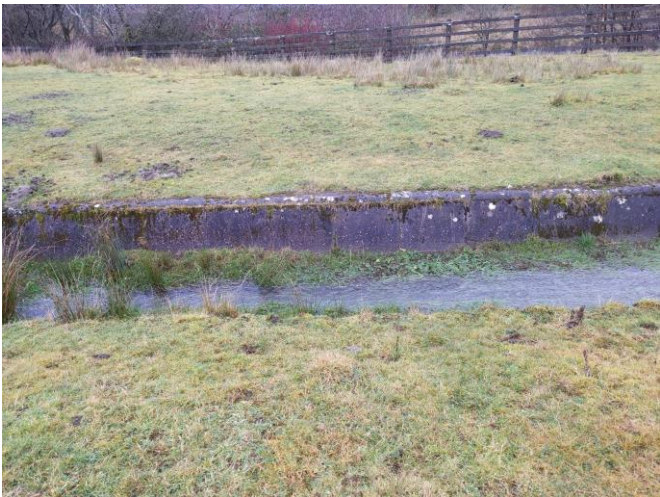
Location: 11
National Grid Reference: SO 10524 08057
Photograph Date: 19/12/2023
Description: Right and left bank material: Concrete and artificial
Right and left bank height: 0.7m
Channel width: 1m
Flow: Smooth. Flowing south.
Some vegetation in the drain.

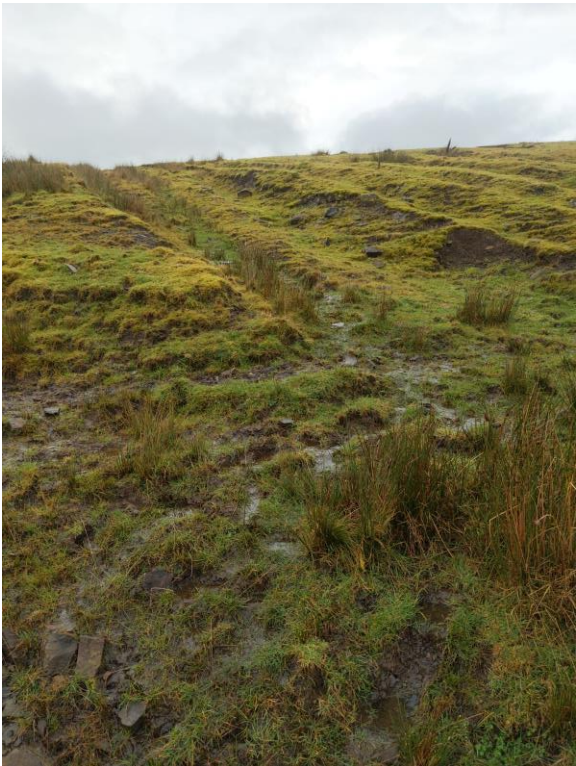
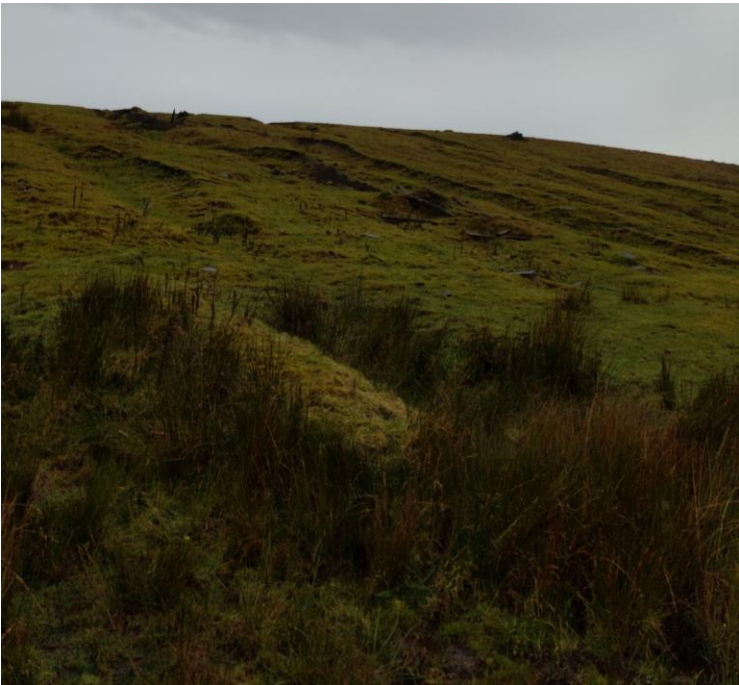
Location: 12
National Grid Reference: SO 10468 08209
Photograph Date: 19/12/2023
Description: Evidence of historic coal mining.

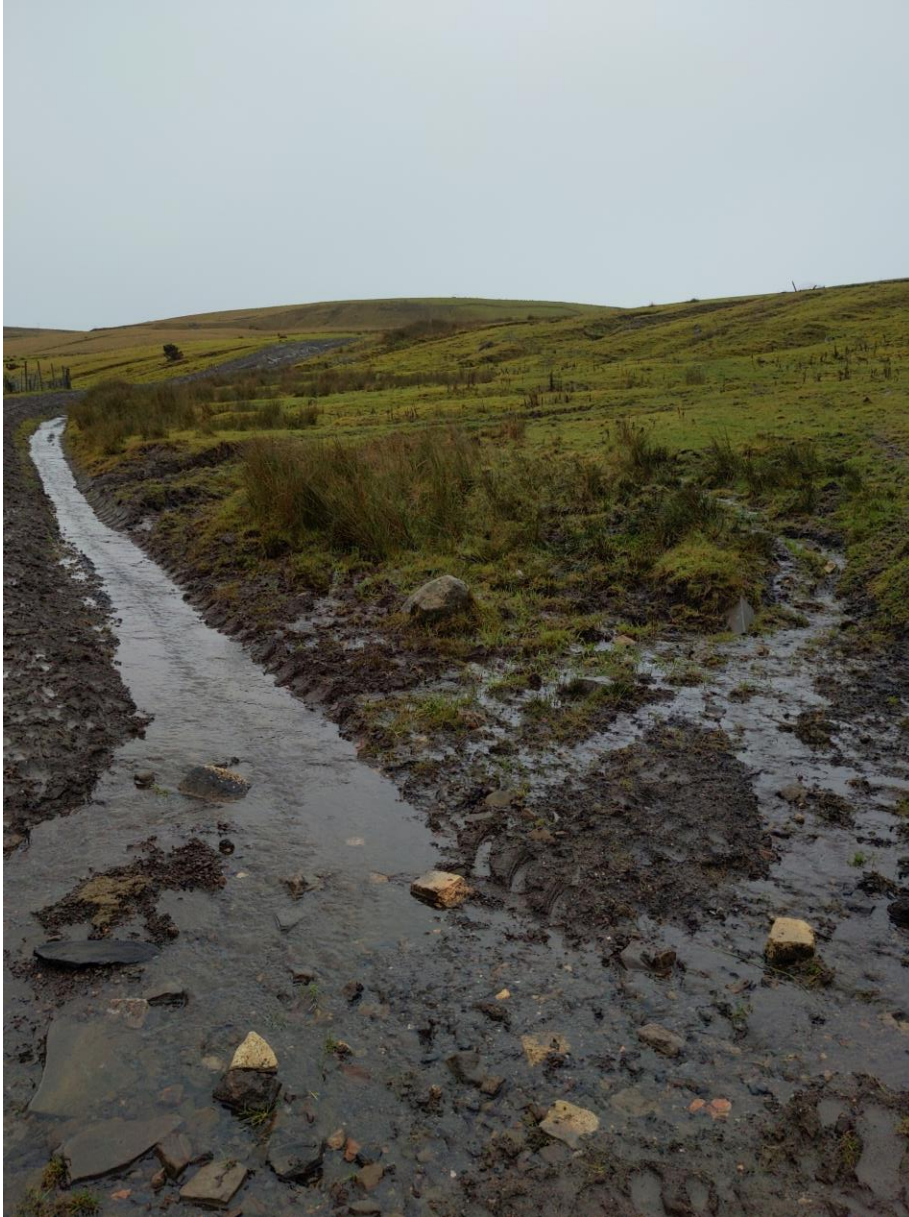
Location: 13
National Grid Reference: SO 10472 08259
Photograph Date: 19/12/2023
Description: Photograph taken facing south.
Surface water run off flowing north into Location 14.

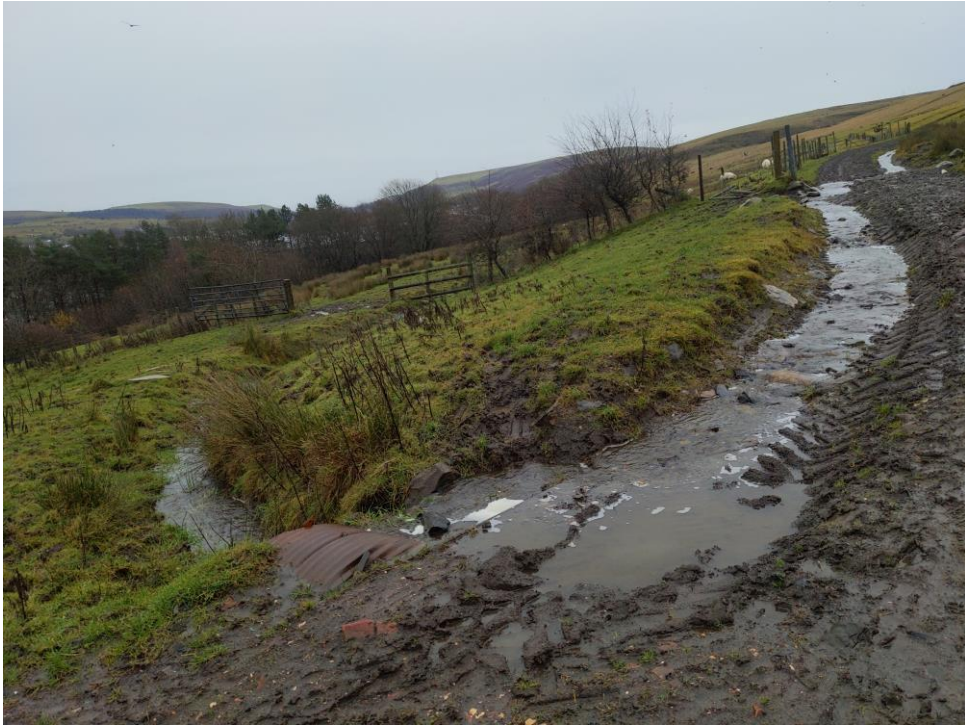
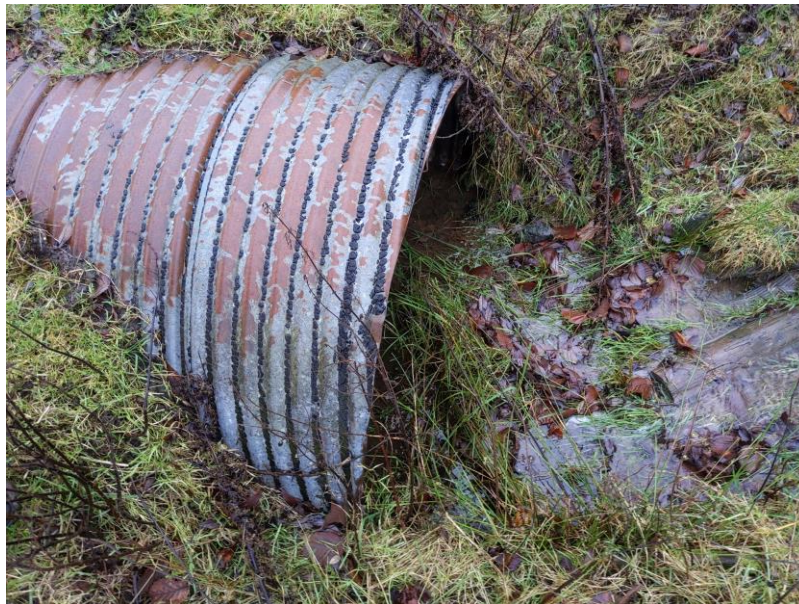
Location: 14
National Grid Reference: SO 10473 08277
Photograph Date: 19/12/2023
Description: Surface water run off flowing north (Location 13) into stream which flows south east.
Channel width: 1m
Channel material: Earth (crumbly) / Bedrock
Water culverted by a metal pipe under track.

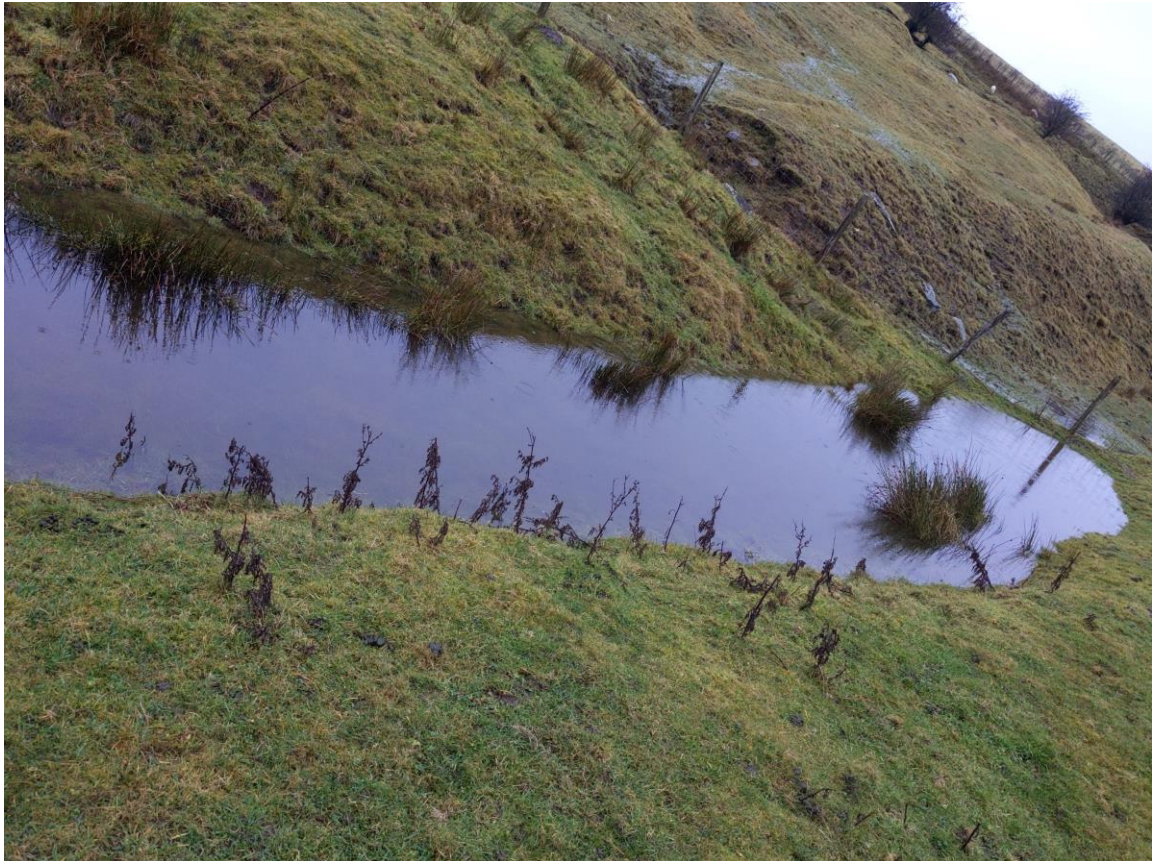
Location: 15
National Grid Reference: SO 10480 08297
Photograph Date: 19/12/2023
Description: Ponded water. Surface water run off flowing east into pond.

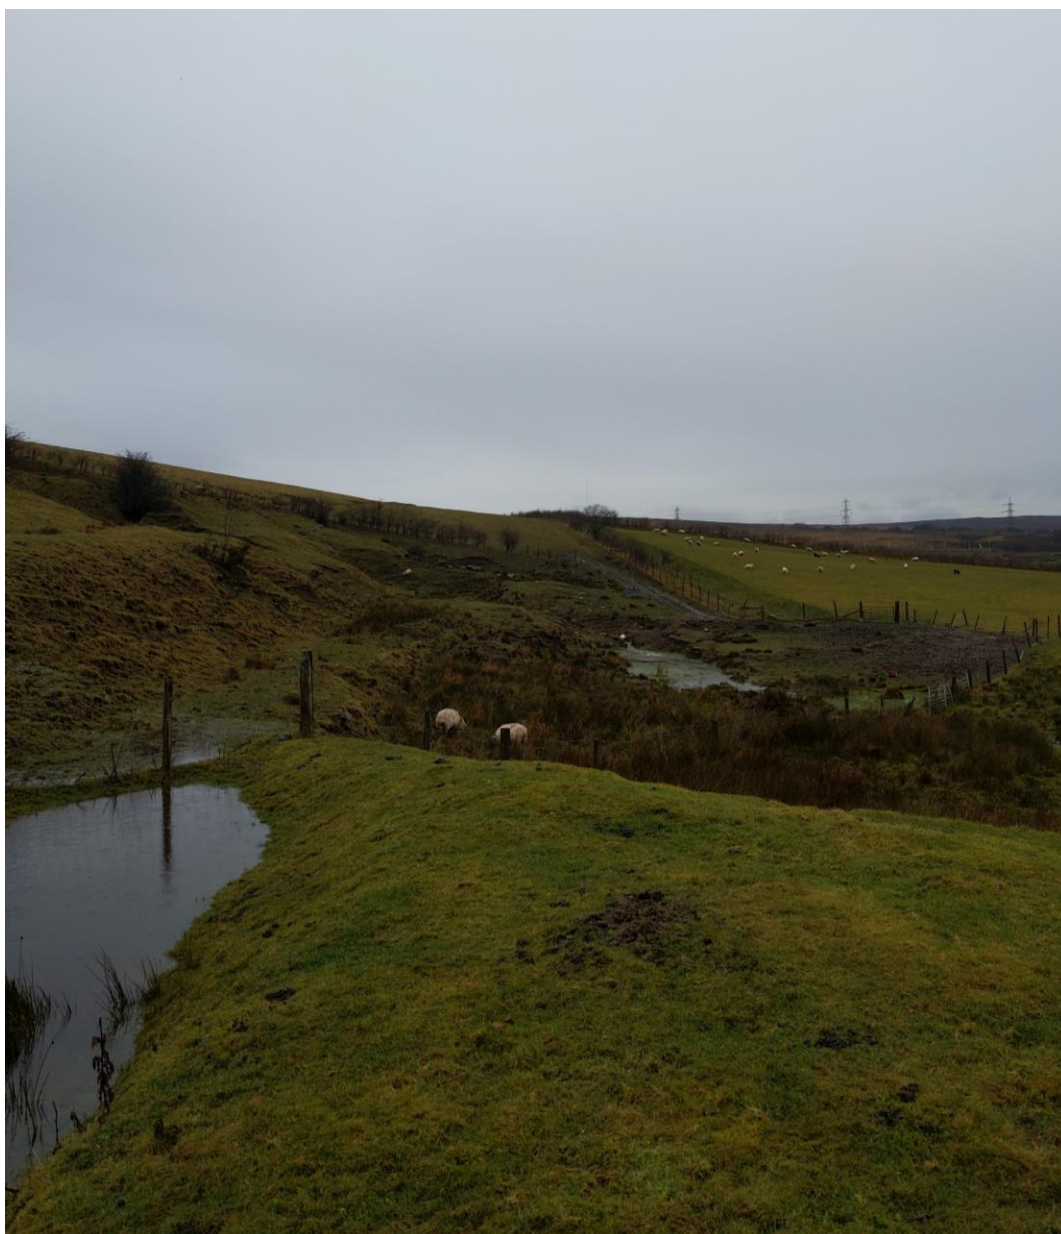
Location: 16
National Grid Reference: SO 10480 08310
Photograph Date: 19/12/2023
Description: Poned water, appears to be part of most northerly, mapped on Site watercourse. Has vegetation / moss on top.

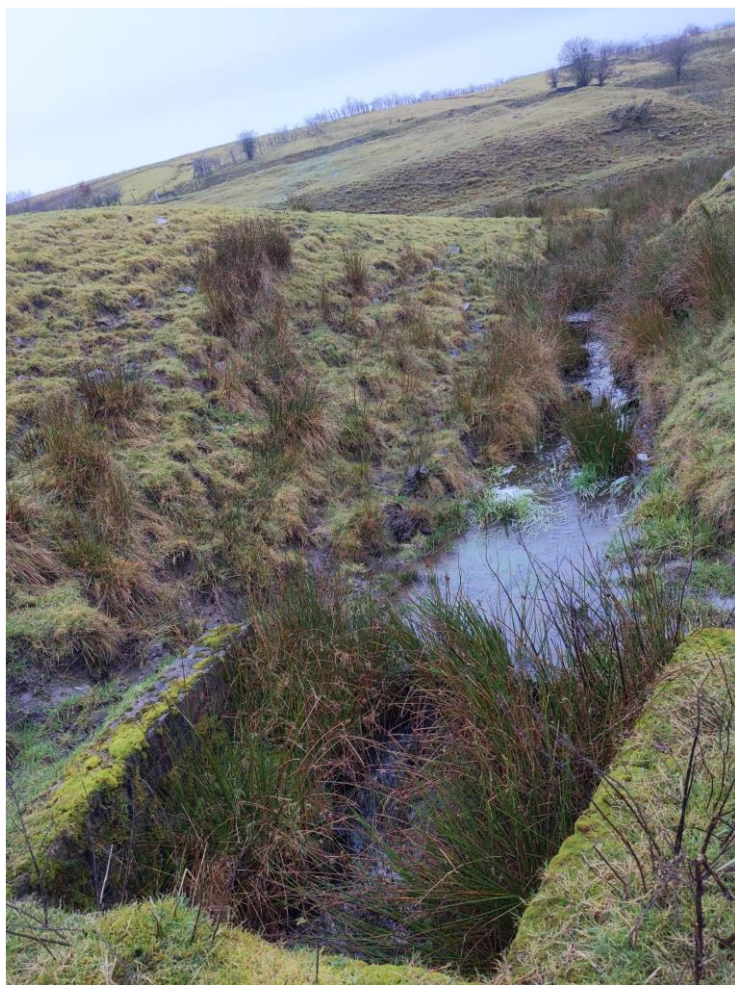
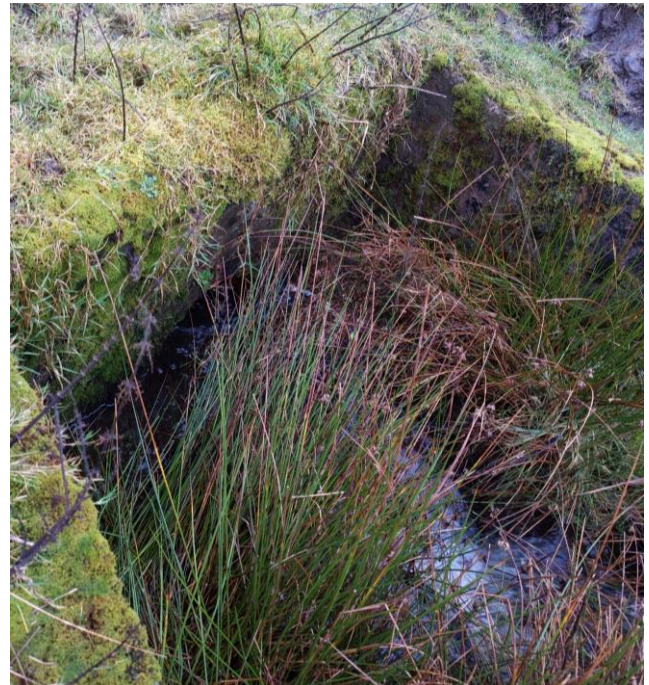
Location: 17
National Grid Reference: SO 10501 08336
Photograph Date: 19/12/2023
Description: Photograph taken looking upstream.
Channel material: Earth (crumbly) / Boulders
Channel width: 1m
Bank height: 2m
Concrete culvert
Flow: smooth. Flowing easterly.
Vegetation in channel

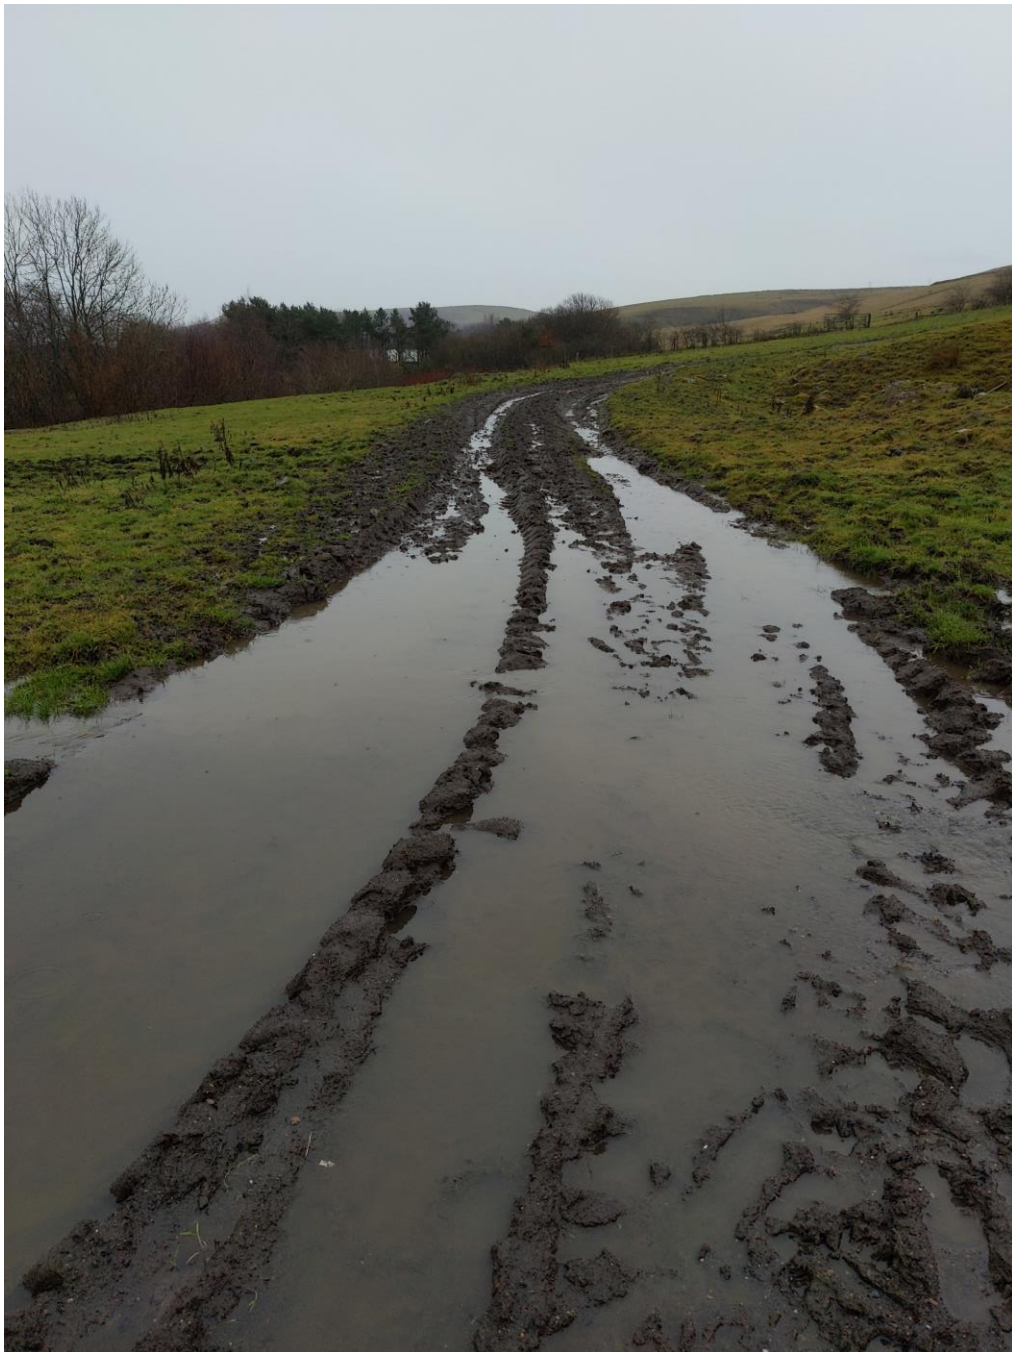
Location: 18
National Grid Reference: SO 10503 08356
Photograph Date: 19/12/2023
Description: Lots of surface water in topographic depression.

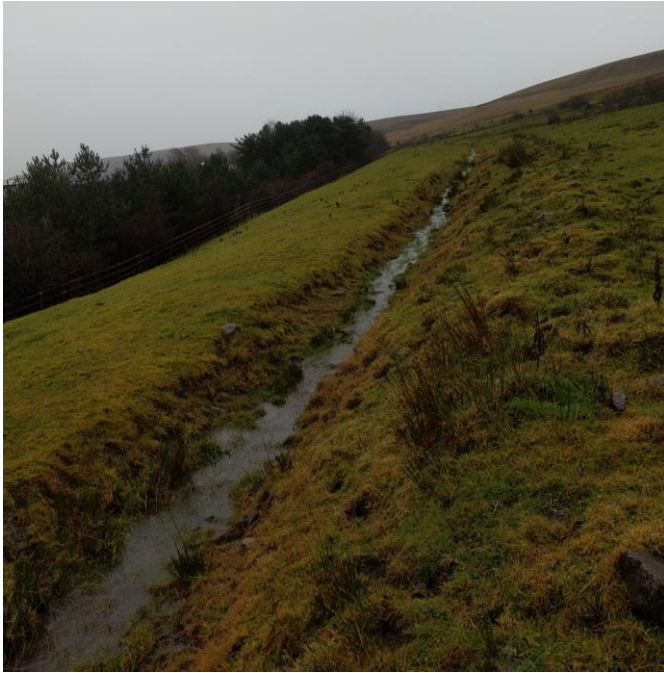
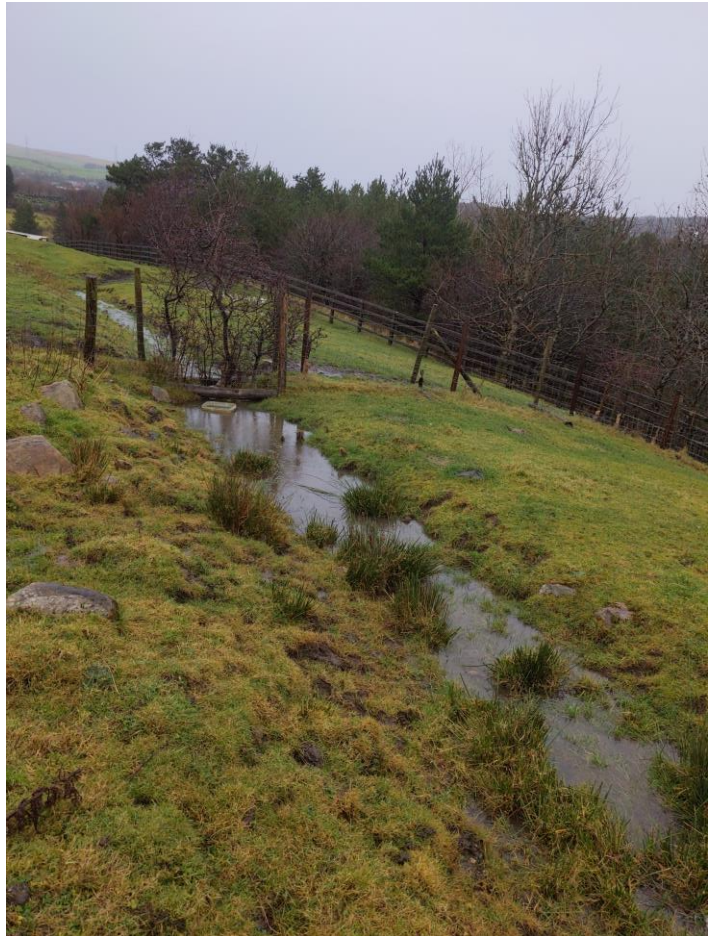
Location: 20
National Grid Reference: SO 10521 08485
Photograph Date: 19/12/2023
Description: On site drainage ditch / field drain. Slightly blocked by vegetation.
Flow: smooth, flowing north into Location 21.
Channel material: Earth (crumbly)
Channel width: 1m
Channel height: 0.5m
Water depth: 0.1m
