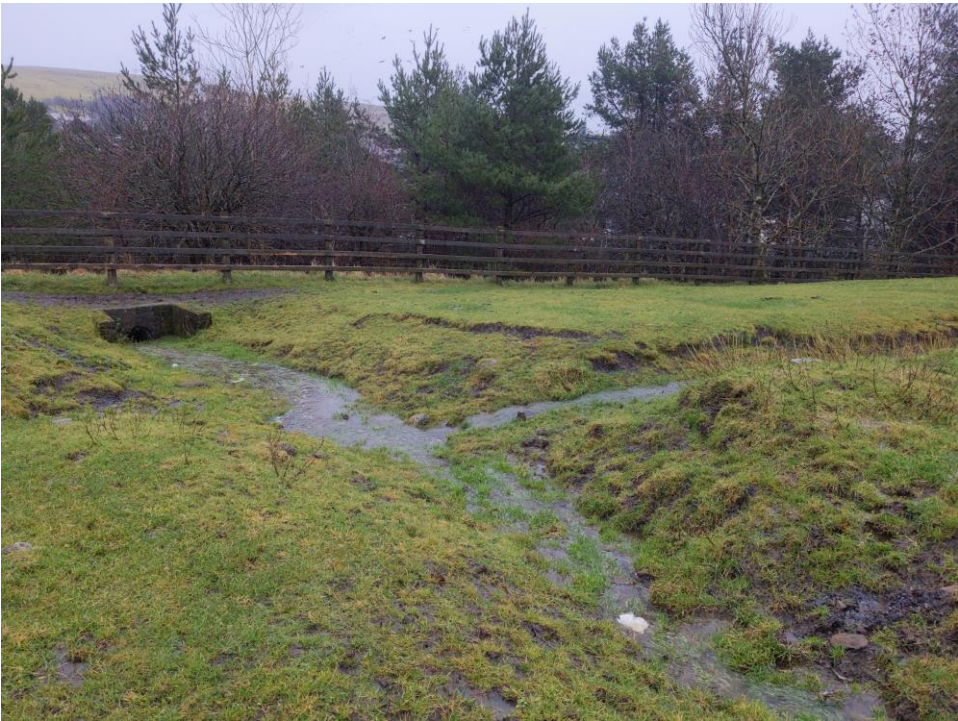
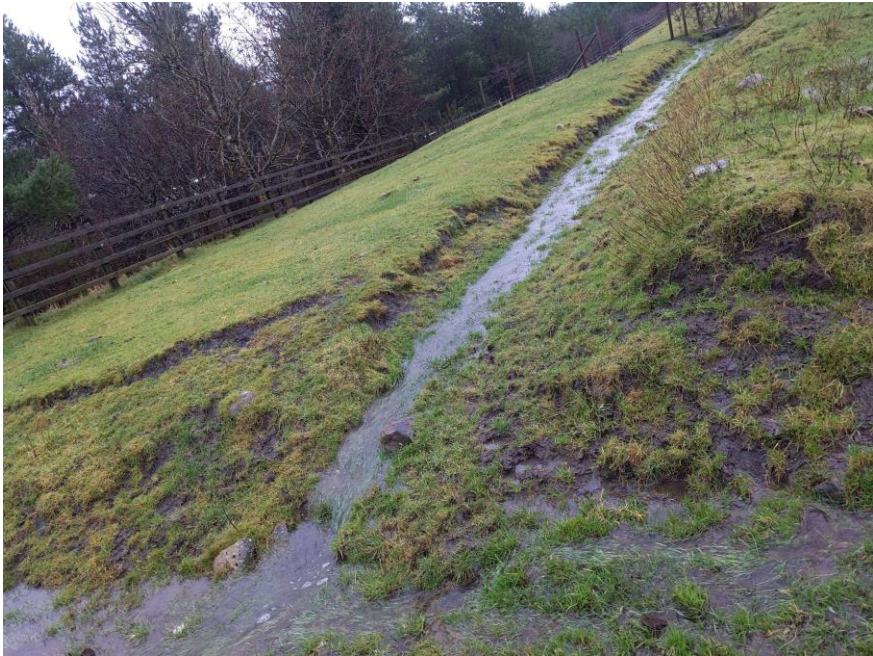
Location: 21
National Grid Reference: SO 10513 08518
Photograph Date: 19/12/2023
Description: On site drainage ditch / field drain. Slightly blocked by vegetation. Concrete culvert where water flows into concrete drainage ditch which flows towards River Rhymney.
Flow: smooth, flowing east into culvert. Bottom photo is Location 20 entering Location 21.
Channel material: Earth (crumbly)
Channel width: 0.5m
Channel height: 0.25m
Water depth: 0.1m

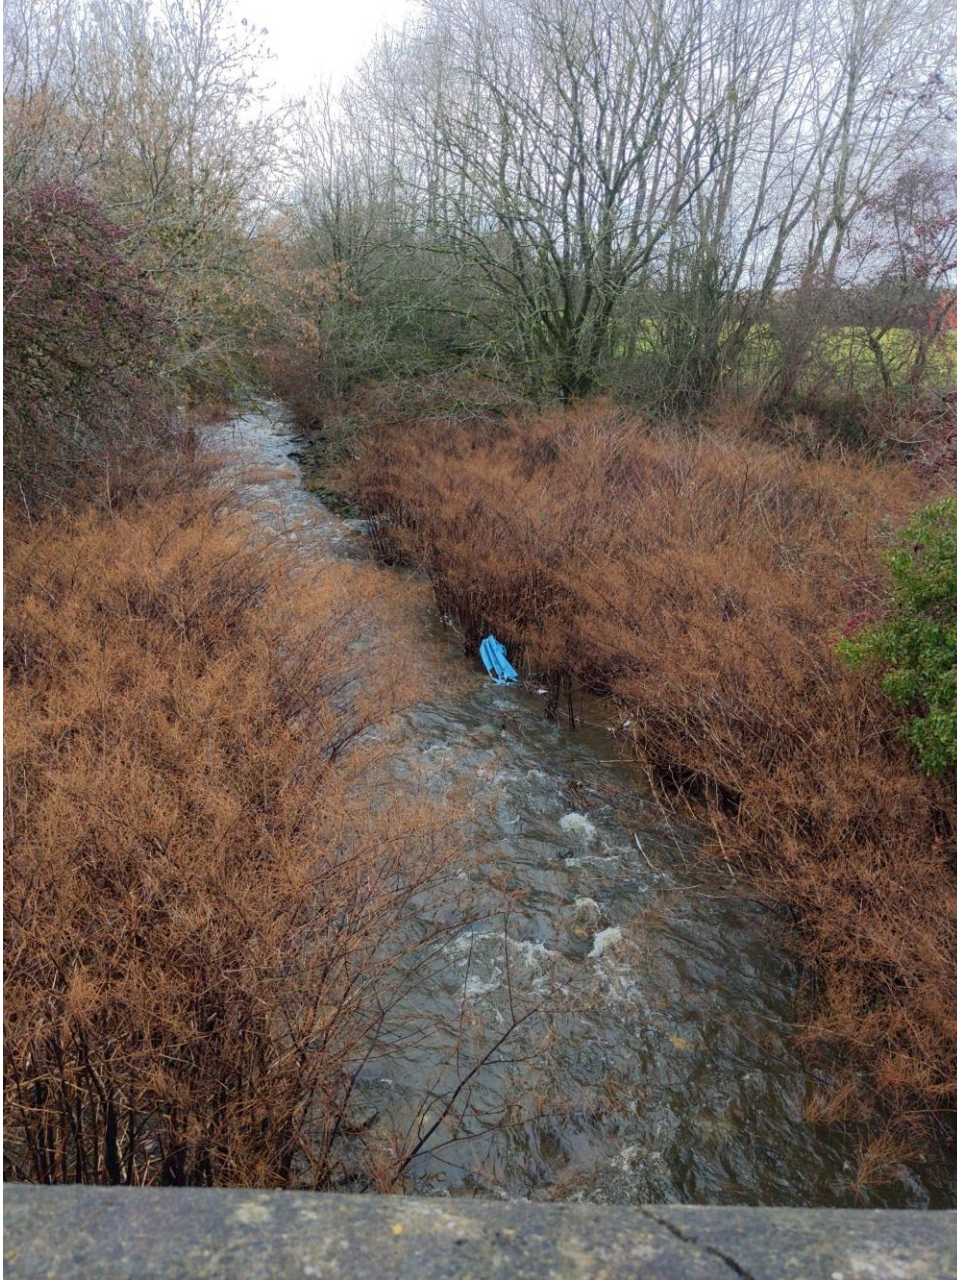
Location: 22
National Grid Reference: SO 10502 08699
Photograph Date: 19/12/2023
Description: Nant Carno.
Photograph taken upstream from a bridge, river is culverted under the road.
Flow: Smooth with some areas chaotic
Channel material: Boulder / Bedrock / Earth (crumbly)
Channel width: 7m

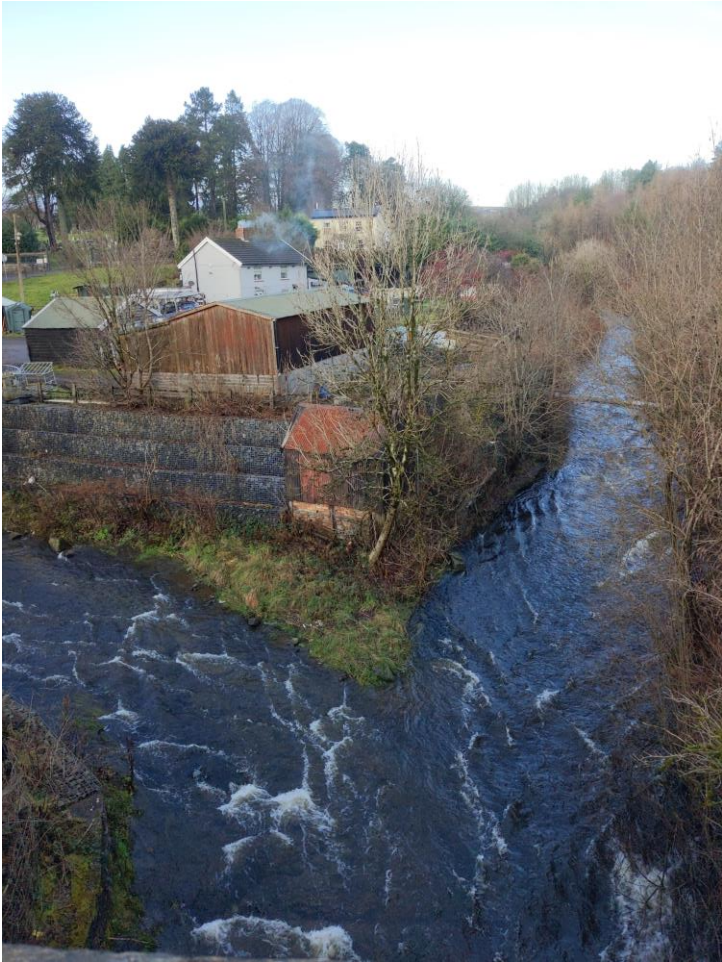
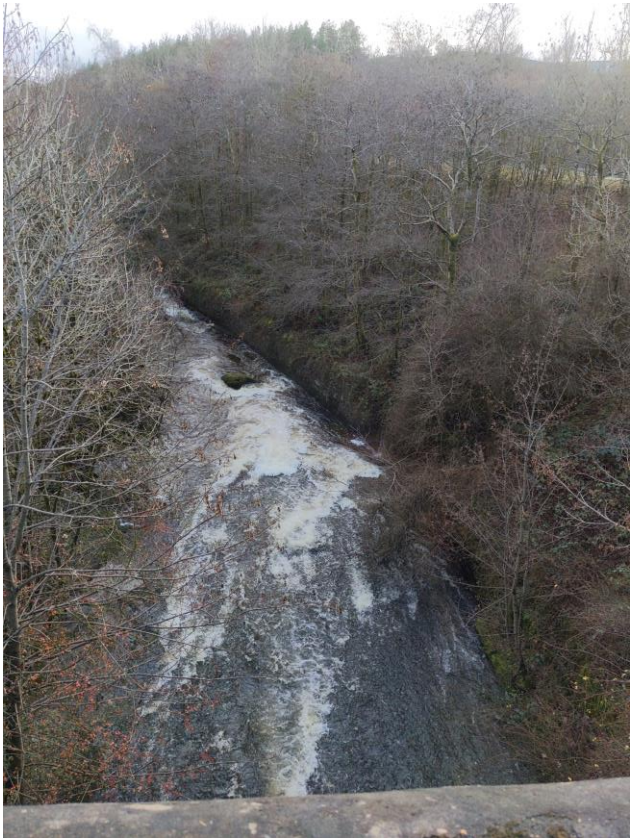
Location: 23
National Grid Reference: SO 10756 08491
Photograph Date: 19/12/2023
Description: Photograph taken from bridge. Left photograph shows the confluence of Nant Carno (left) and the River Rhymney (right).
Flow: Southerly direction, chaotic and very fast flow.
Channel material: Brick / manmade / concrete
Channel width: 10m
Bank height: 15m
Some boulders in the middle of the river.
Some inflows from banks at the sides.

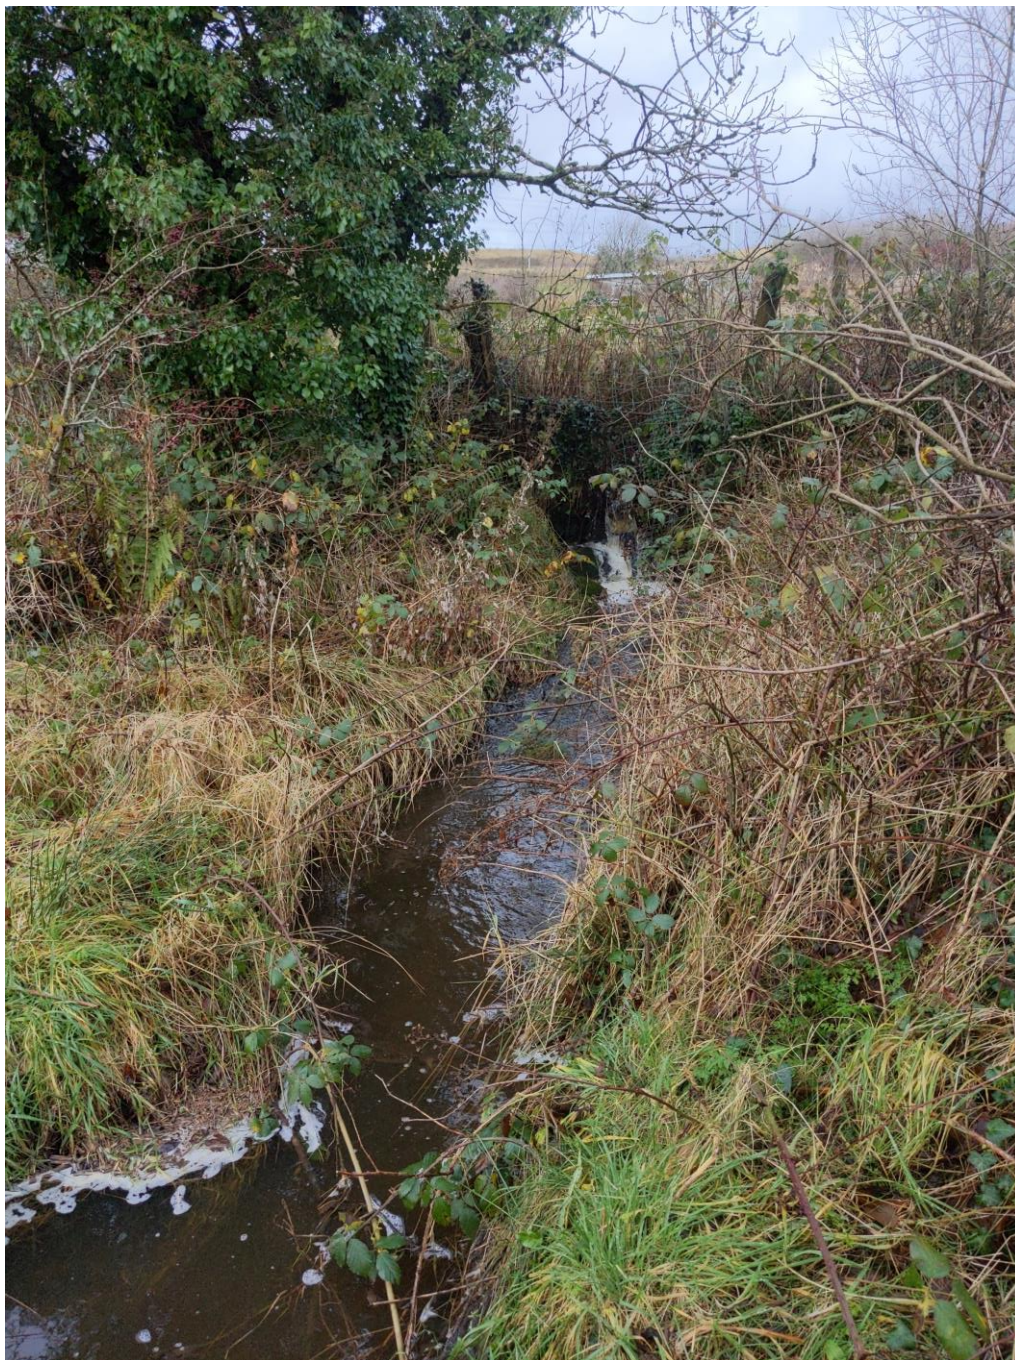
Location: 26
National Grid Reference: SO 10201 09190
Photograph Date: 19/12/2023
Description: Smooth inflow into Butetown reservoir. Flowing south.
Channel width: 0.75m.
Channel material: Earth (crumbly).

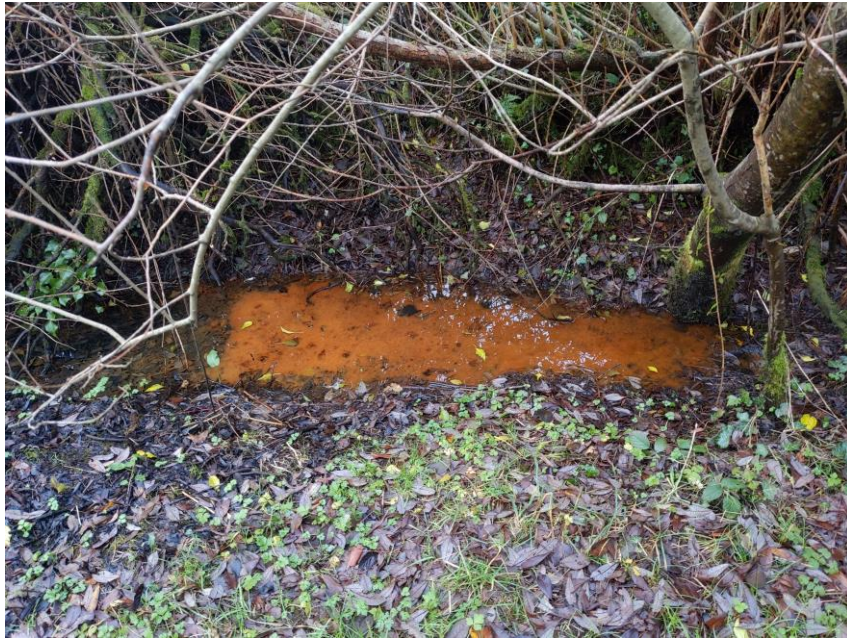
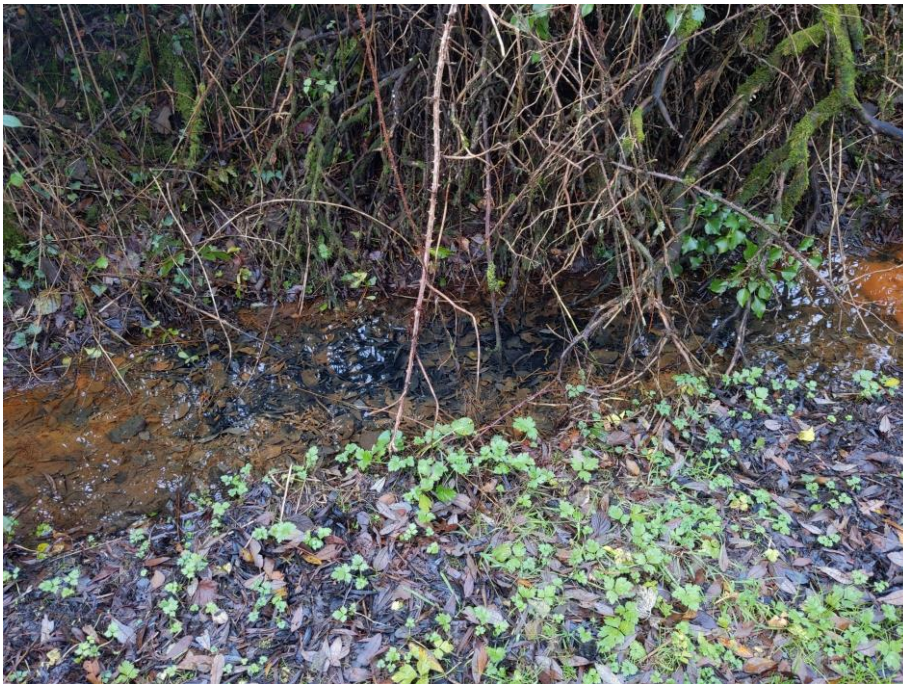
Location: 27
National Grid Reference: SO 10107 09208
Photograph Date: 19/12/2023
Description: Acid drainage in field drain next to Butetown reservoir.

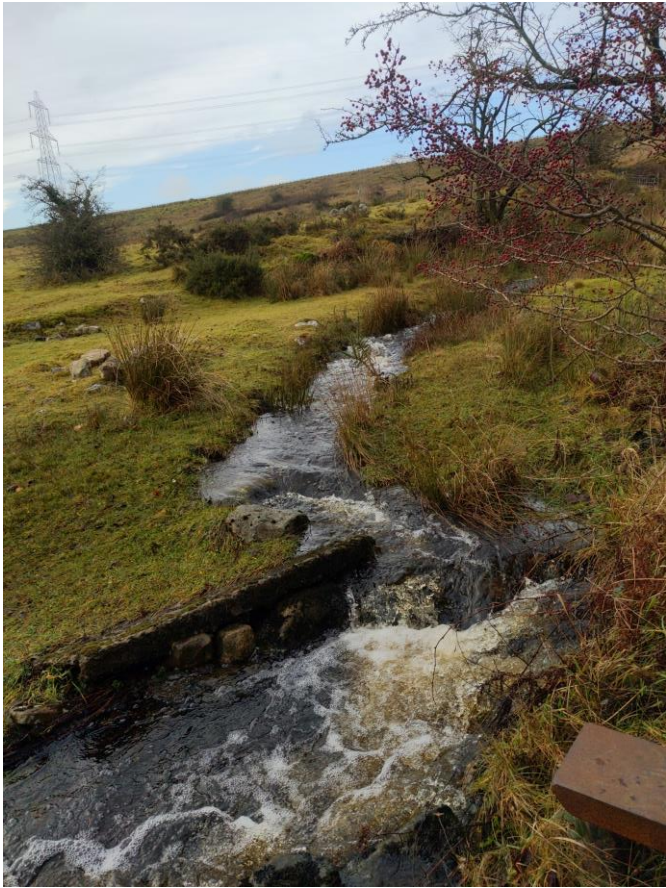
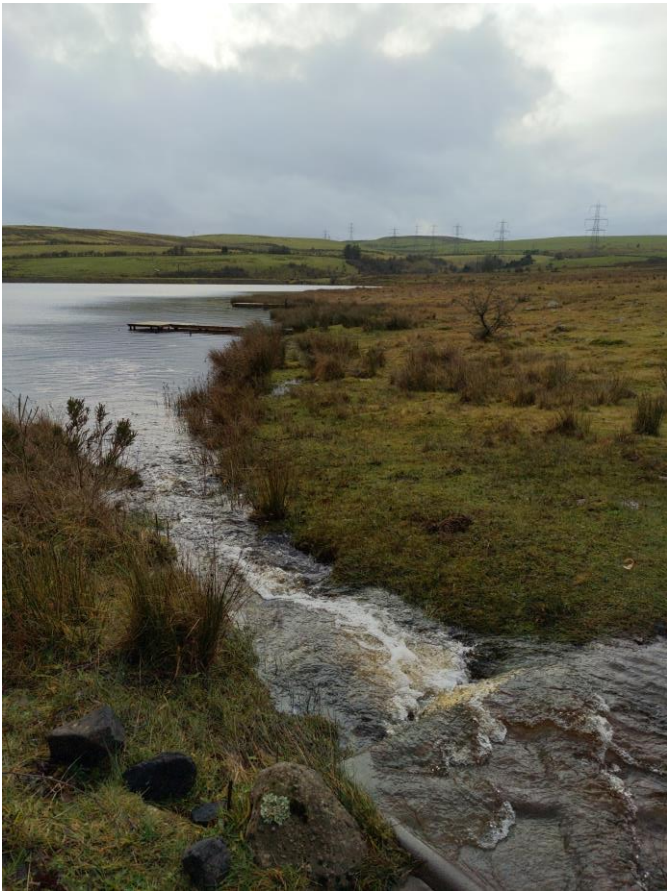
Location: 28
National Grid Reference: SO 09982 09139
Photograph Date: 19/12/2023
Description: Inflow into Butetown reservoir.
Flow: chaotic and fast, south into reservoir. Artificially redirected.
Channel material: Artificial / Earth (crumbly) / Boulder
Channel width: 0.8m
Channel height: 0.5m
Water had a yellow tinge.

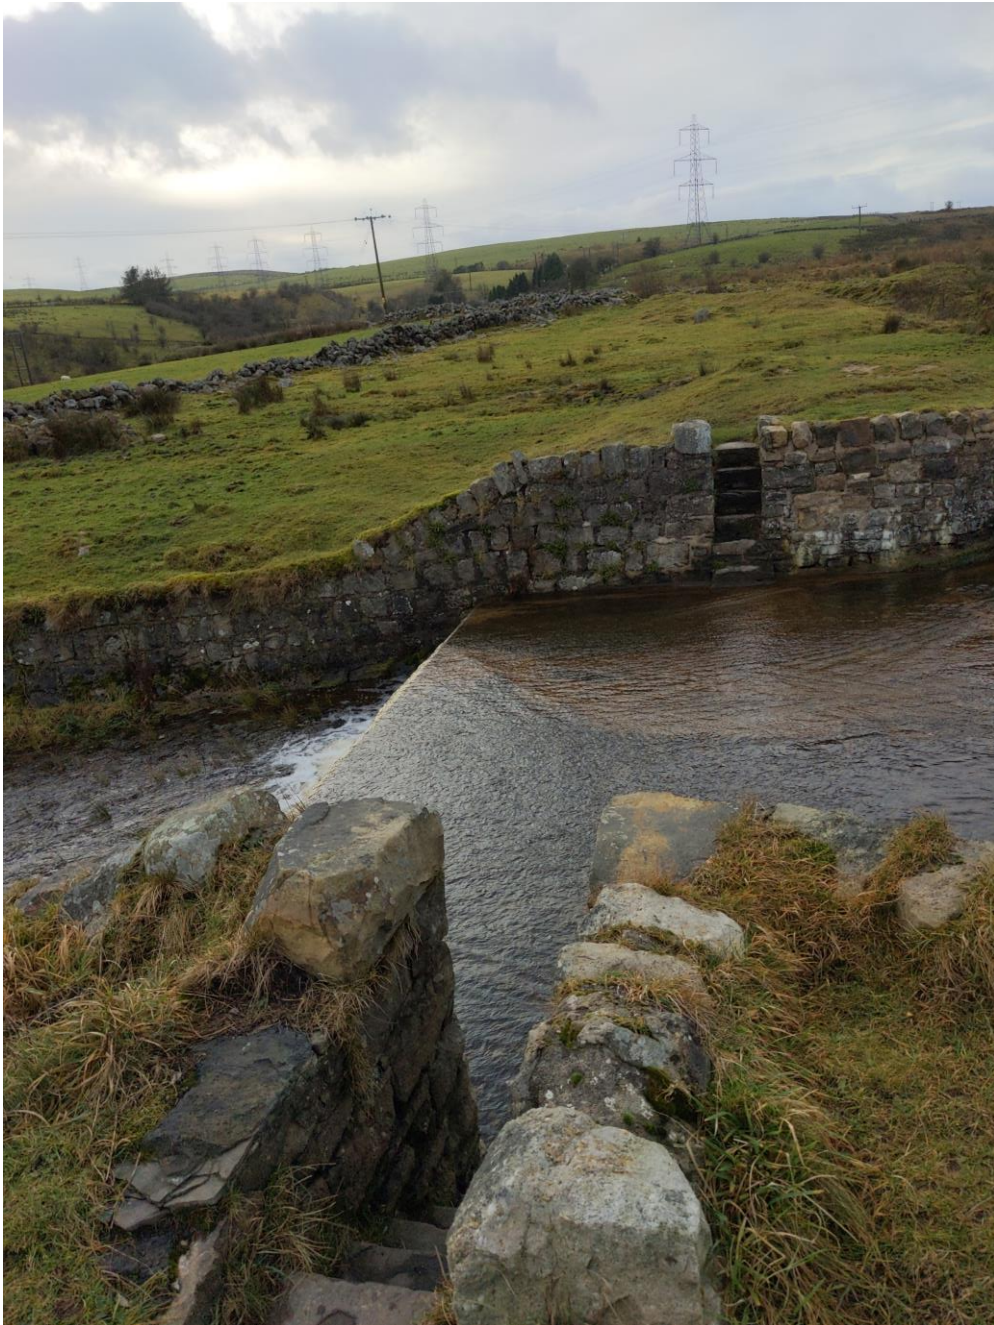
Location: 29
National Grid Reference: SO 09851 08913
Photograph Date: 19/12/2023
Description: Butetown reservoir outflow / weir.
Flow: smooth, east into Nant Carno.
Manmade / brick / concrete / laid stone.
Channel width: 4m
Water depth: approximately 0.5m
Channel artificially diverted.
