<b>CLIENT:</b>	Convatec Limited
<b>PROJECT:</b>	PEP Wind and Solar Development
<b>SUBJECT:</b>	Peat and Soil Technical Note
<b>JOB NO.:</b>	BR10167
<b>DATE:</b>	30/01/2024
<b>PREPARED BY:</b>	Gruffydd Jones
<b>REVIEWED &amp; APPROVED BY:</b>

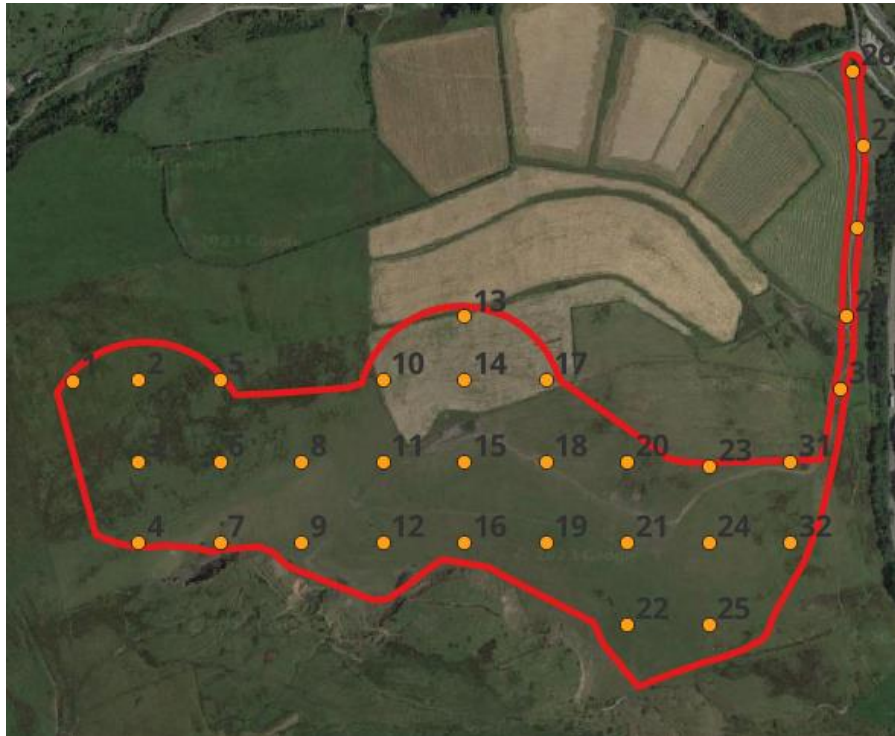
- 3.2.2 The site was surveyed for peat using the above definition at predefined locations on a 100 m x 100 m grid within the site boundary (Figure 1). Whilst the survey points were predefined, signs of possible peat presence such as changes in the vegetation, water regime and ground conditions were noted during the walkover, to ensure that smaller areas of peat were not missed during the survey.

**Figure 1: Peat probing locations (Basemap © Google Satellite) (mapping to provide updated map once boundary is finalised).**

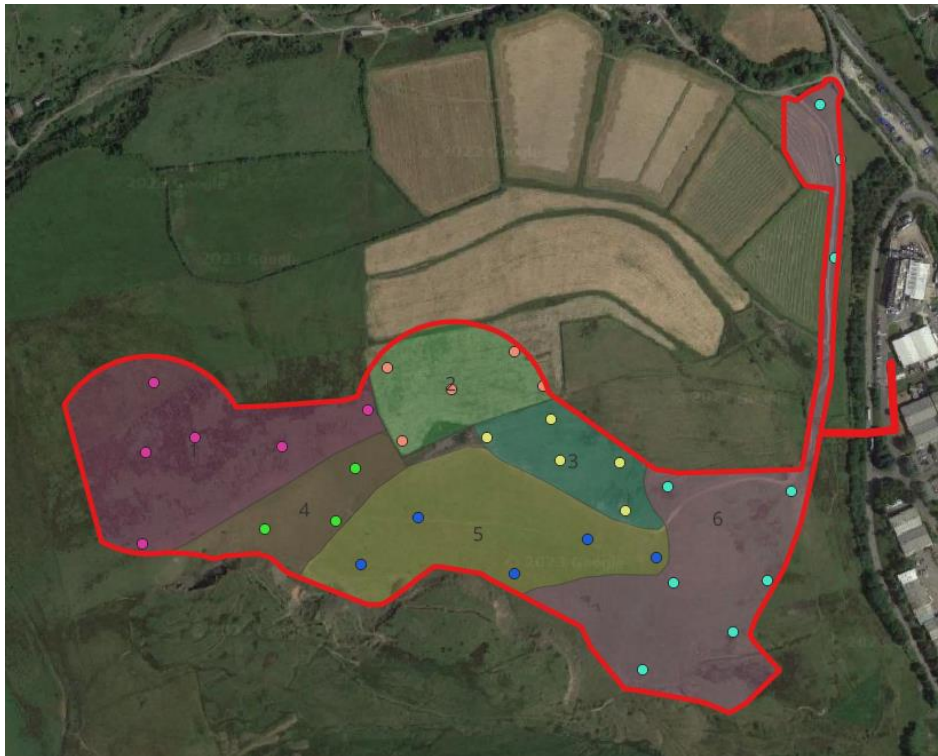
- 3.3.1 The site was split into six sub-areas based on the topography, vegetation type, and land use (Figure 2). The soil was surveyed using a “free survey” design rather than using predetermined survey locations in order to ensure a representative distribution across the site whilst retaining the ability to provide more detail in areas of sensitive or variable soils and detect abrupt changes in soil type in the field.

**Figure 2: The six soil sampling areas within the site and the specific points where subsampling was conducted (Basemap © Google Satellite) (mapping to provide updated map once boundary is finalised).**

- 4.1.1 No peat was found at any of the probing points shown in Figure 2. The topsoil was a shallow organic-mineral<sup>7</sup> soil throughout the site, as discussed below.

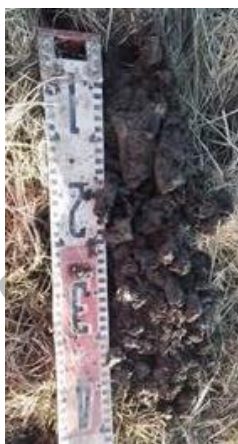
a – Area 1 point 5

- 4.2.2 The topsoil across the site ranged from 10 to 20 cm (Photographs 1a, 1b and 1c). The deepest topsoils (up to 20 cm) were found on the parts of the site with lower lying land or shallower gradients (northern parts of Areas 1 and 2 in particular), whilst the topsoil was shallower on the ridgeline in Area 1 and the slopes of Areas 3, 4, 5 and 6 (10-15 cm).

**Photograph 1: Variation in topsoil depth throughout the site. Photograph 1c displays the on the clayey subsoil horizon only found in this part of the site.**

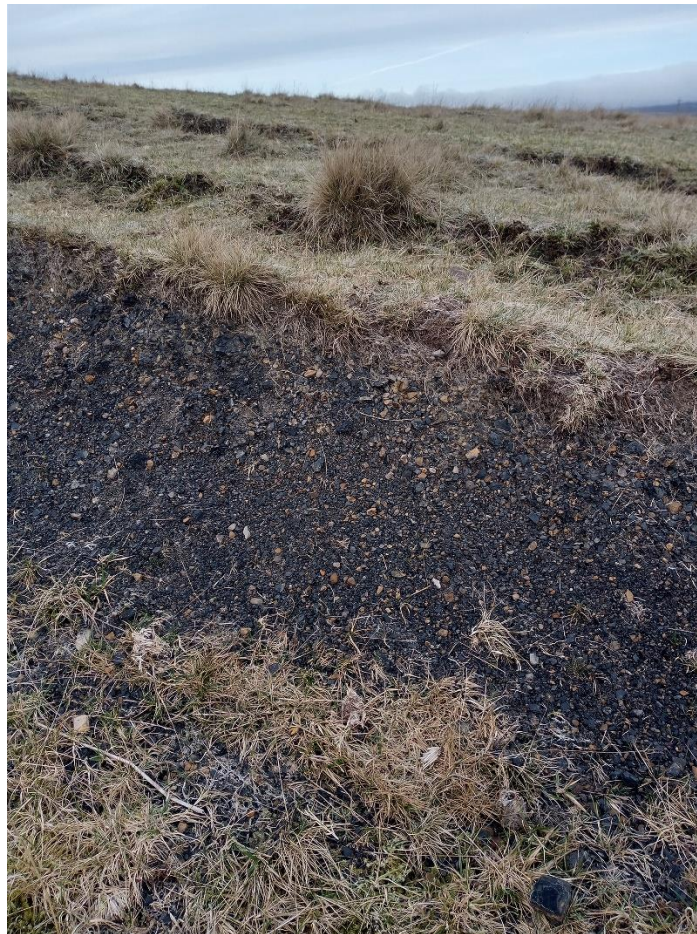
- 4.2.5 The topsoil overlies a layer of a dark, coarse substrate (Photograph 2) which is a legacy of the historic surface coal mining conducted in the area. An assessment of this horizon was beyond the scope of this report, however, it was found consistently throughout the site apart from one point (Area 6, point 6) where a clay subsoil was recorded (Photograph 1c).

**Photograph 2: Exposed soil profile due to localised erosion in Area 6. A thin topsoil layer (<10 cm) overlies a layer of opencast spoil.**

- 5.1.6 To avoid loss of topsoil quality through mixing with the underlying subsoil or spoil, both topsoil and subsoil should be stripped and stored separately in clearly defined stockpiles. This should be informed by the SMP which will detail the depths to which different areas of soil are to be stripped.
