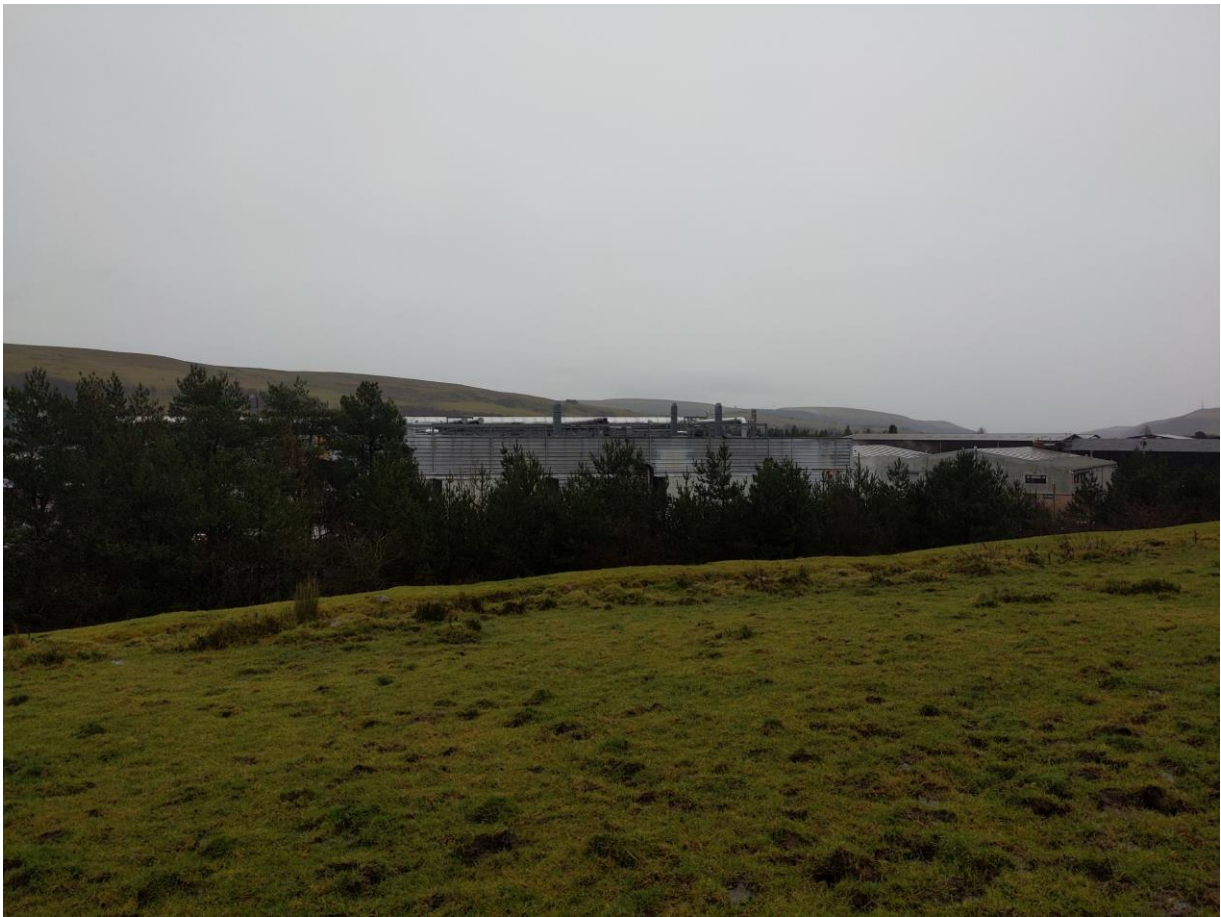
Location: 19
National Grid Reference: SO 10504 08468
Photograph Date: 19/12/2023
Description: Industrial park next to site. Photograph taken facing east.

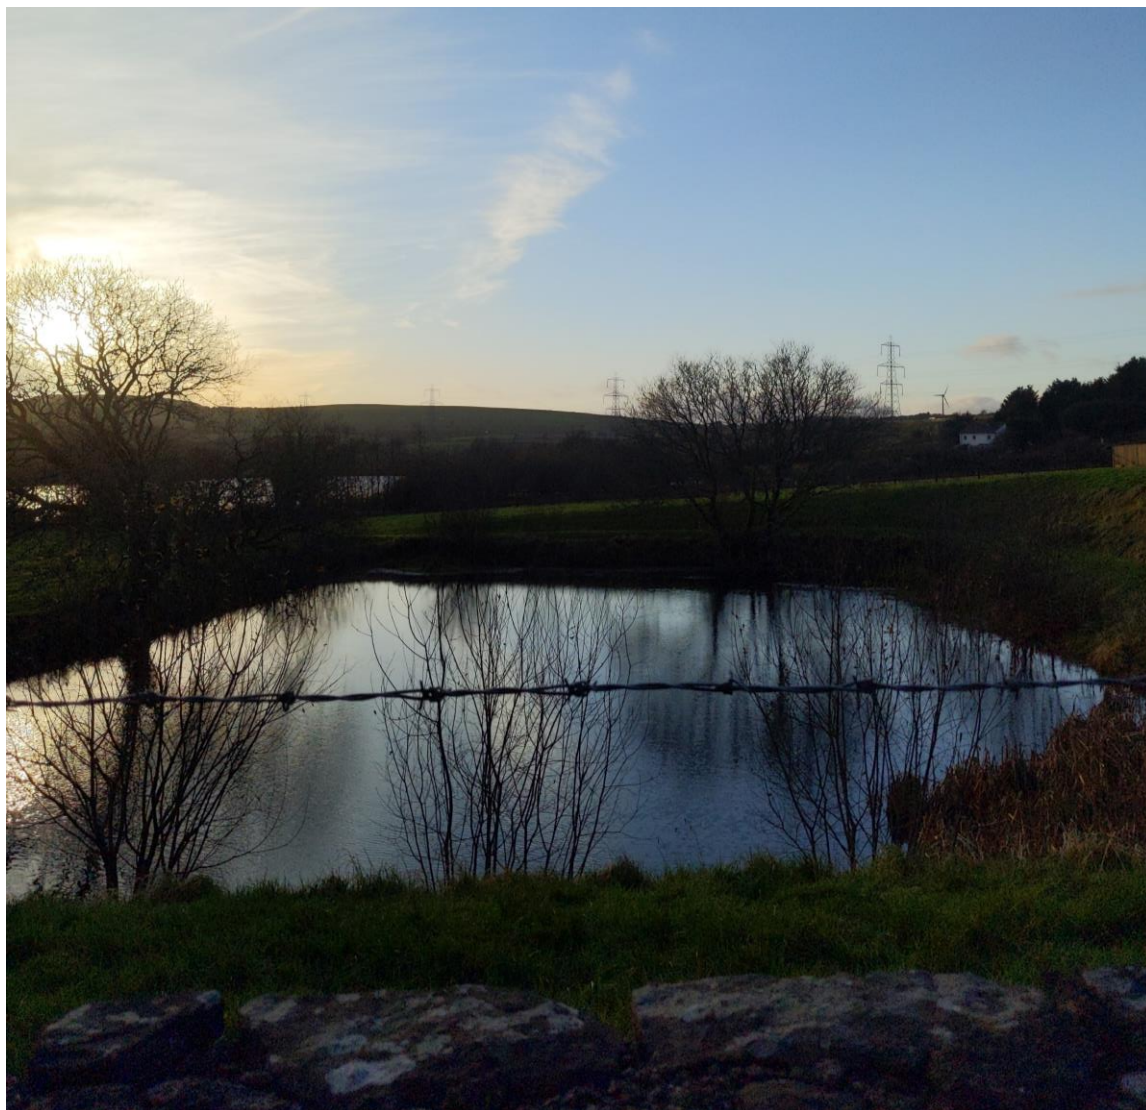
Location: 24
National Grid Reference: SO 10293 09264
Photograph Date: 19/12/2023
Description: Small reservoir next to Butetown reservoir, associated with Lakeside Farm. Purpose not known. Photograph taken over brick wall.

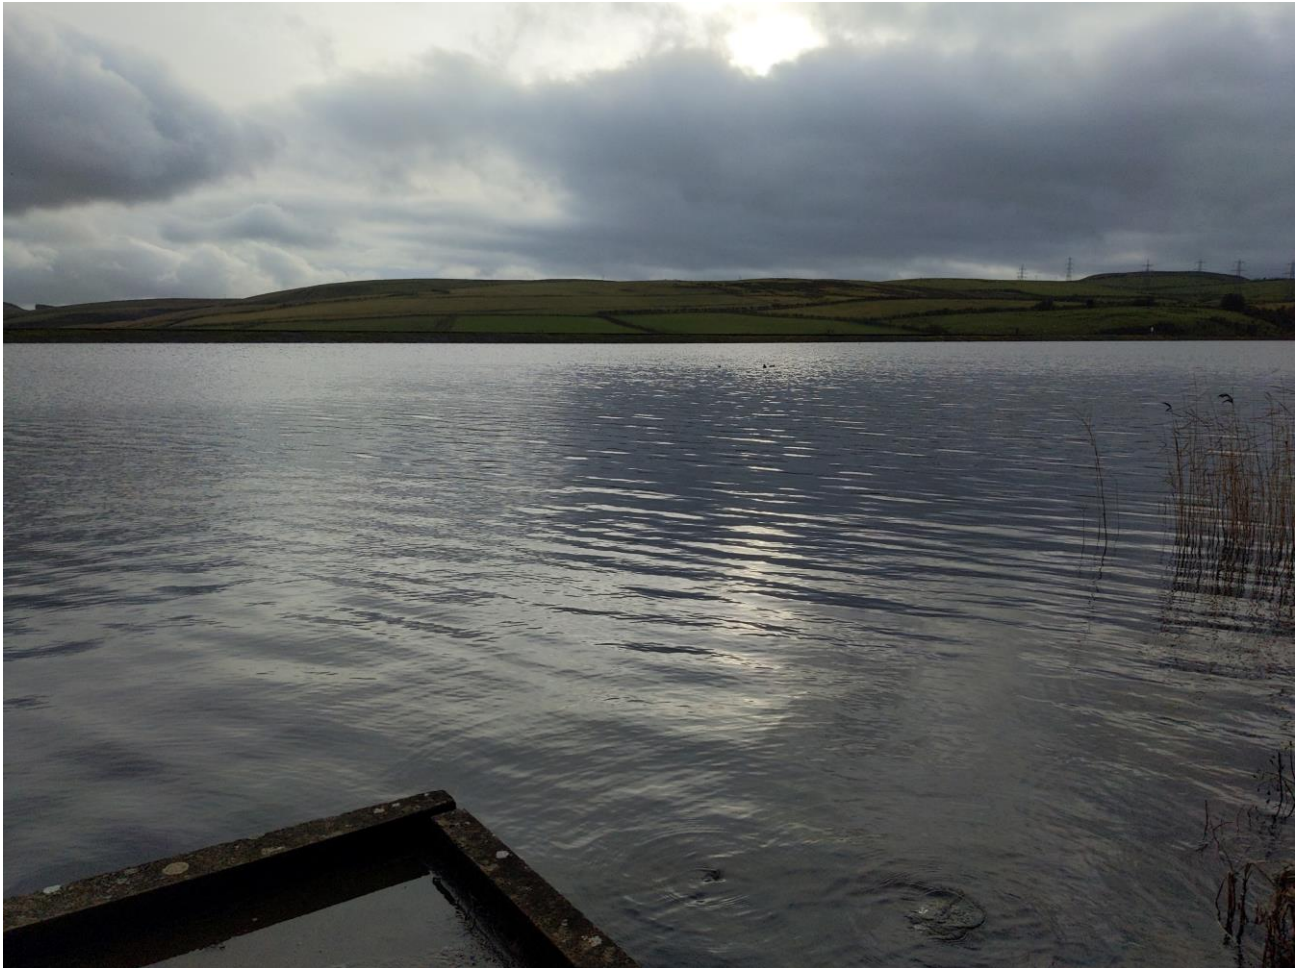
Location: 25
National Grid Reference: SO 10272 09210
Photograph Date: 19/12/2023
Description: Butetown reservoir. No visible flow. Used for fishing.
